# GABION MESH CORROSION

## Field Study of Test Panels and Full-scale Facilities

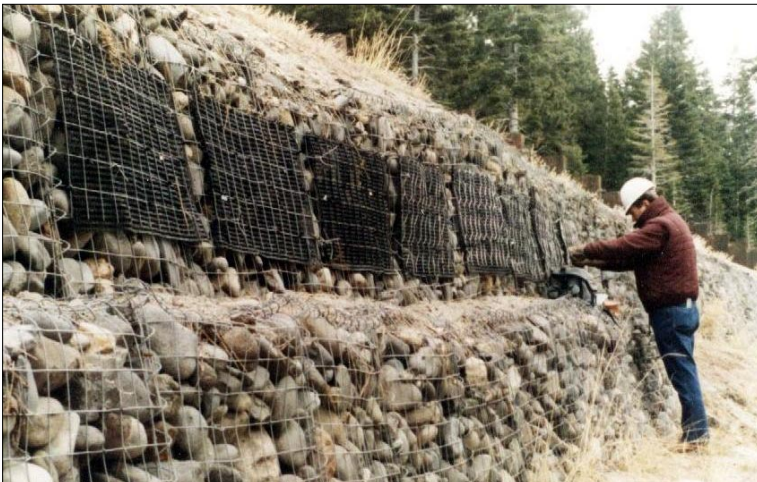
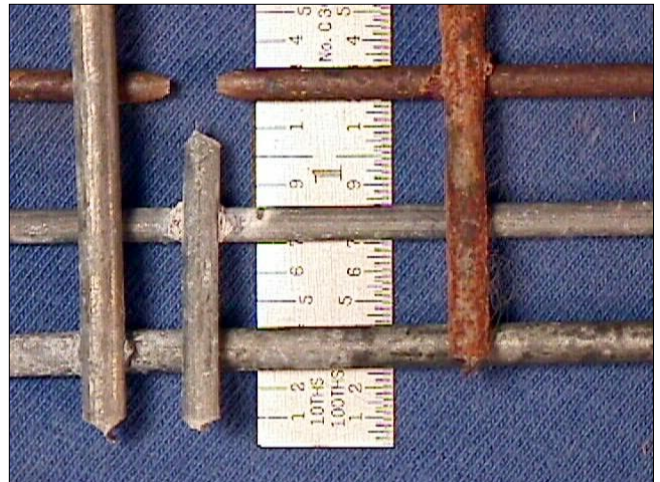
STATE of CALIFORNIA  
DEPARTMENT of TRANSPORTATION  
DIVISION of NEW TECHNOLOGY and RESEARCH

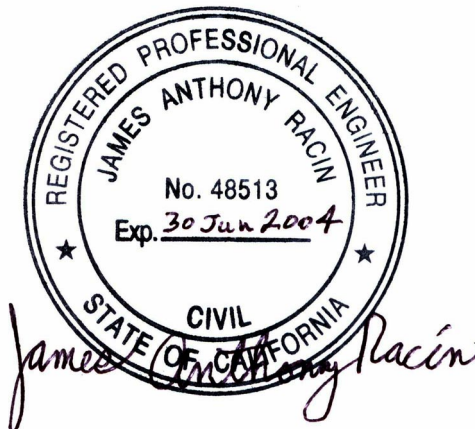
1. REPORT No. <b>FHWA-CA-TL-99-23</b>	2. GOVERNMENT ACCESSION No. <b>PB2001-102895</b>	3. RECIPIENT'S CATALOG No.	
4. TITLE AND SUBTITLE <b>GABION MESH CORROSION Field Study of Test Panels and Full-scale Facilities</b>		5. REPORT DATE <b>2<sup>nd</sup> edition NOV 2001 (1<sup>st</sup> ed. May 2001)</b>

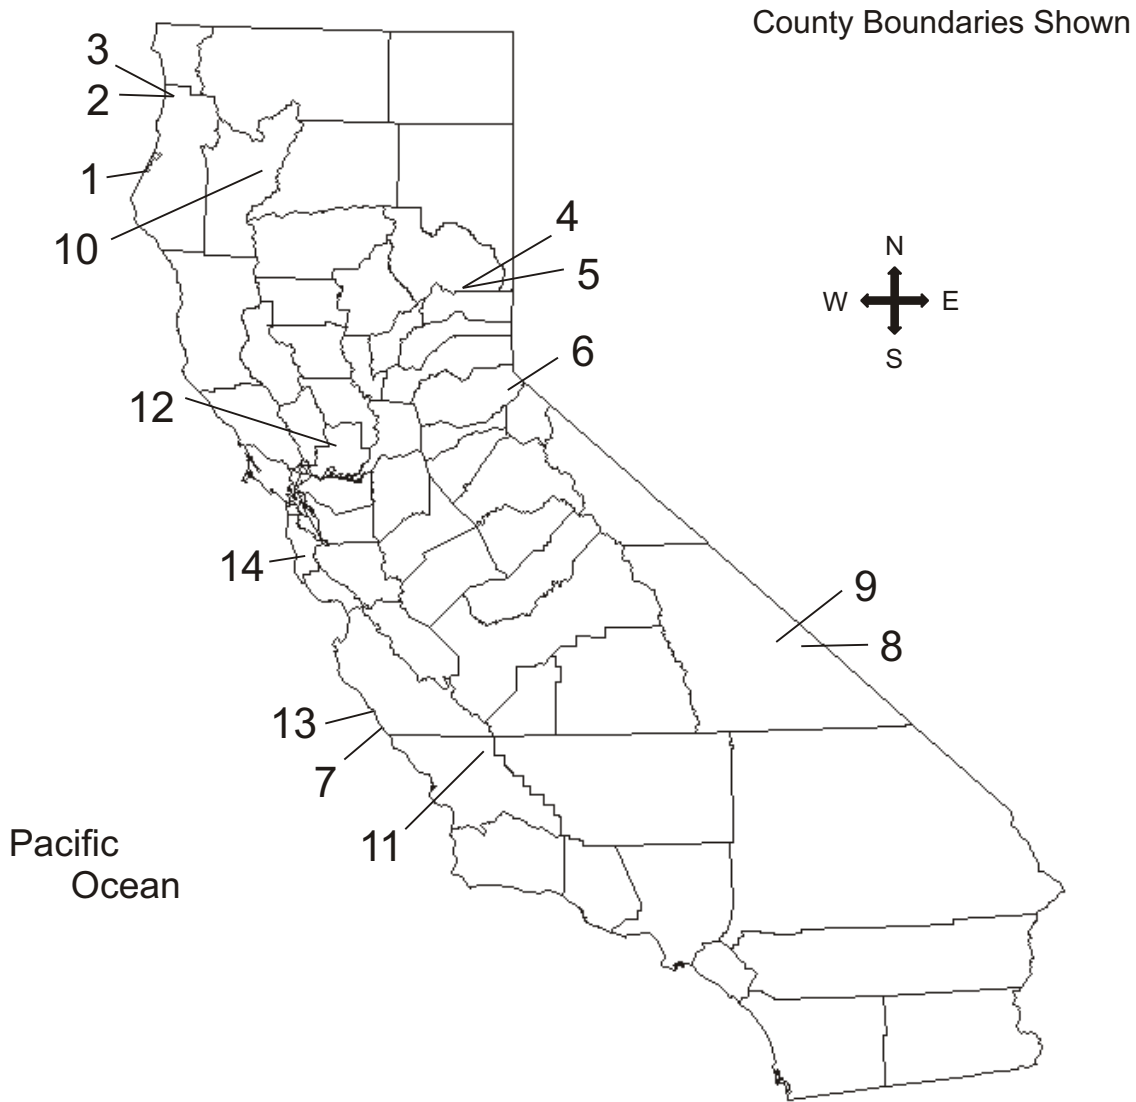
**Table 1. Site Designations and Locations**

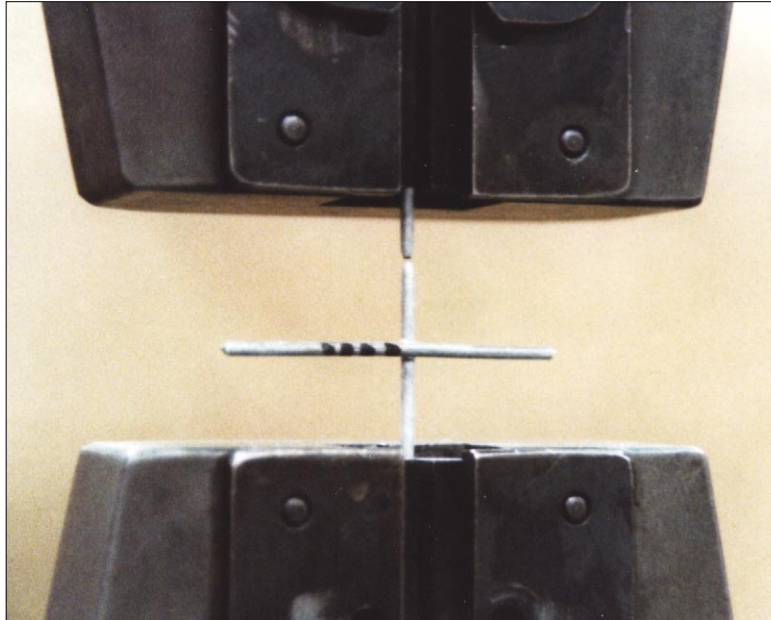
Photo 1. Welded wire in SATEC tensile test machine grips, just after breaking. All breaks were ductile, and wire necked-down before failure. If a wire broke in the machine grips (jaws), then that result was not reported and another test was run. There were only a few jaw breaks among several hundred tensile tests in both the lab and field studies.

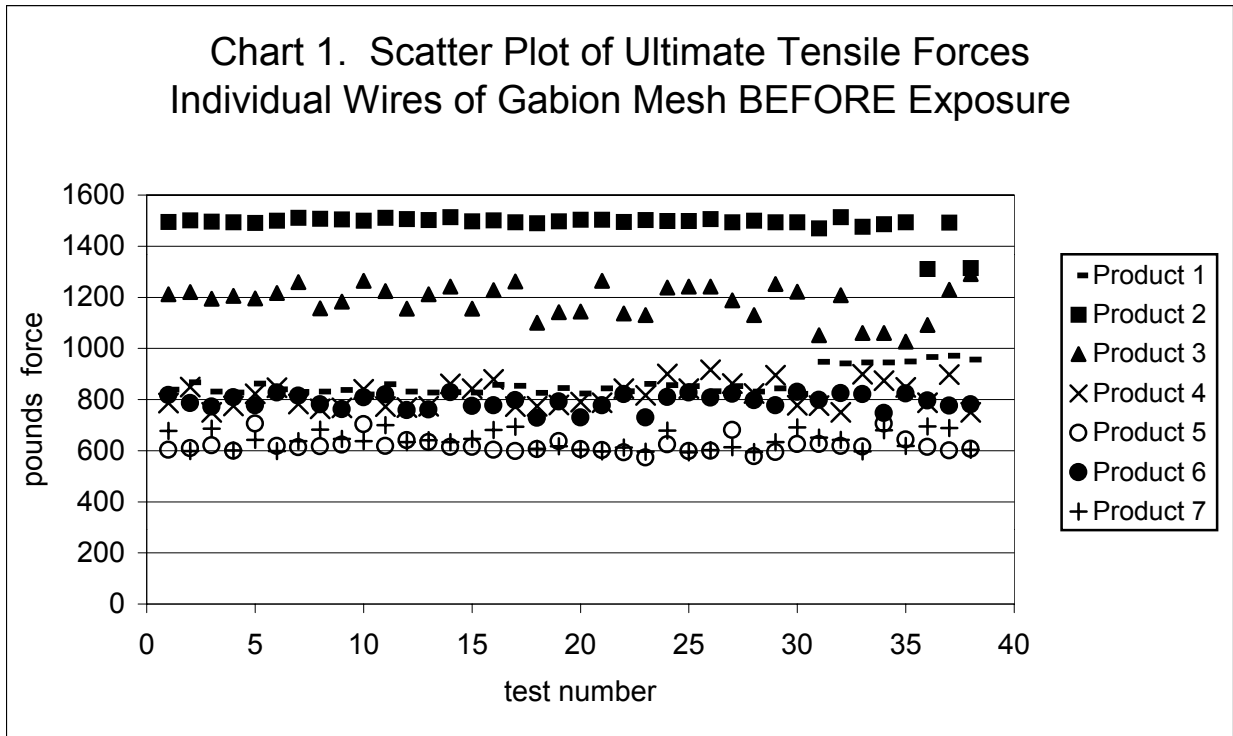
## BEFORE EXPOSURE - TENSILE TESTS

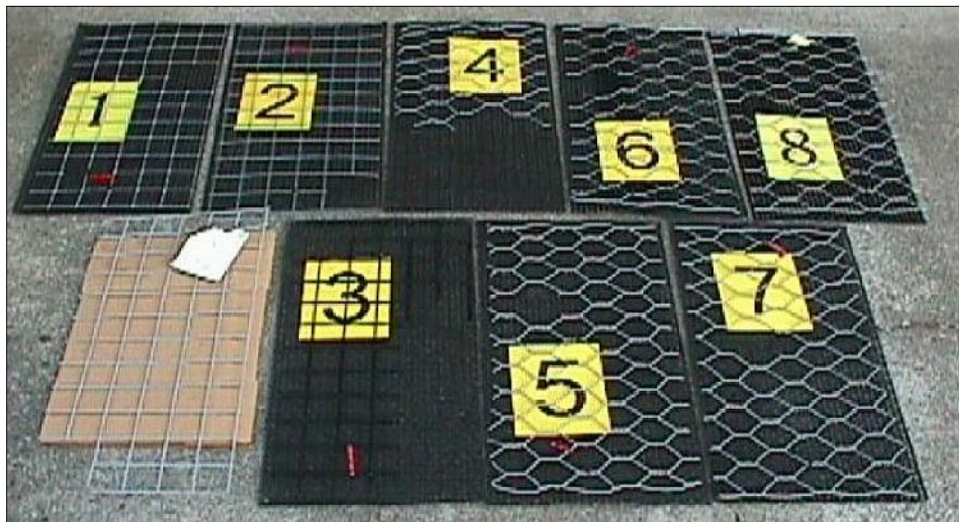
Photo 2. 18-inch by 36-inch CONTROL test panels. Locked indoors and out of sunlight for about 10 years. Wire samples clipped from the control panels were matched against the test panels at field sites and the full-scale facilities. Portions of panels 3 and 4 were used to repair cut-zones of full-scale gabions that were sampled. Products 1, 2, 3, and lower left half panel are welded square-grid gabion mesh. Products 4, 5, 6, 7, and 8 are twisted hexagonal gabion mesh. Products 1, 2, 4, and 6, are zinc-coated, product 8 is aluminum coated, products 3, 5, and 7 are PVC-coated. Black background is core of HDPE (high density polyethylene) geocomposite drain, for insulating test panels from full-scale gabions. Lower left panel was the control for 11-gage gray PVC-coated welded square-grid mesh, road slope protection at site 9. See Table 2 in Chapter 1 for wire gages and manufacturers.

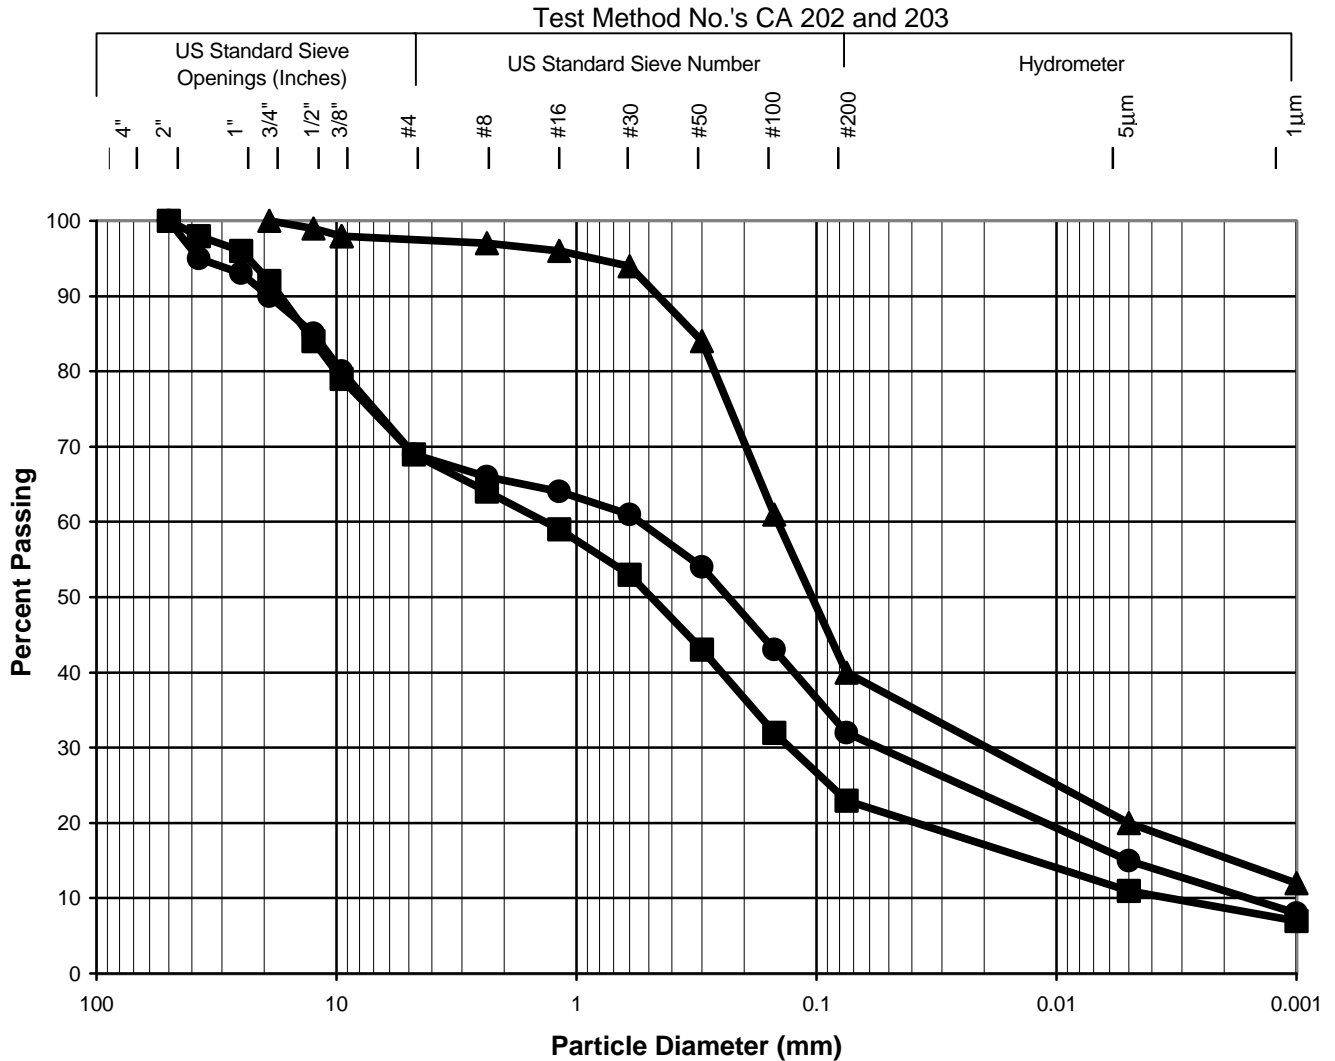
**Figure 3-2. Soil Particle Size Distribution Curves, Sites 4 and 5**

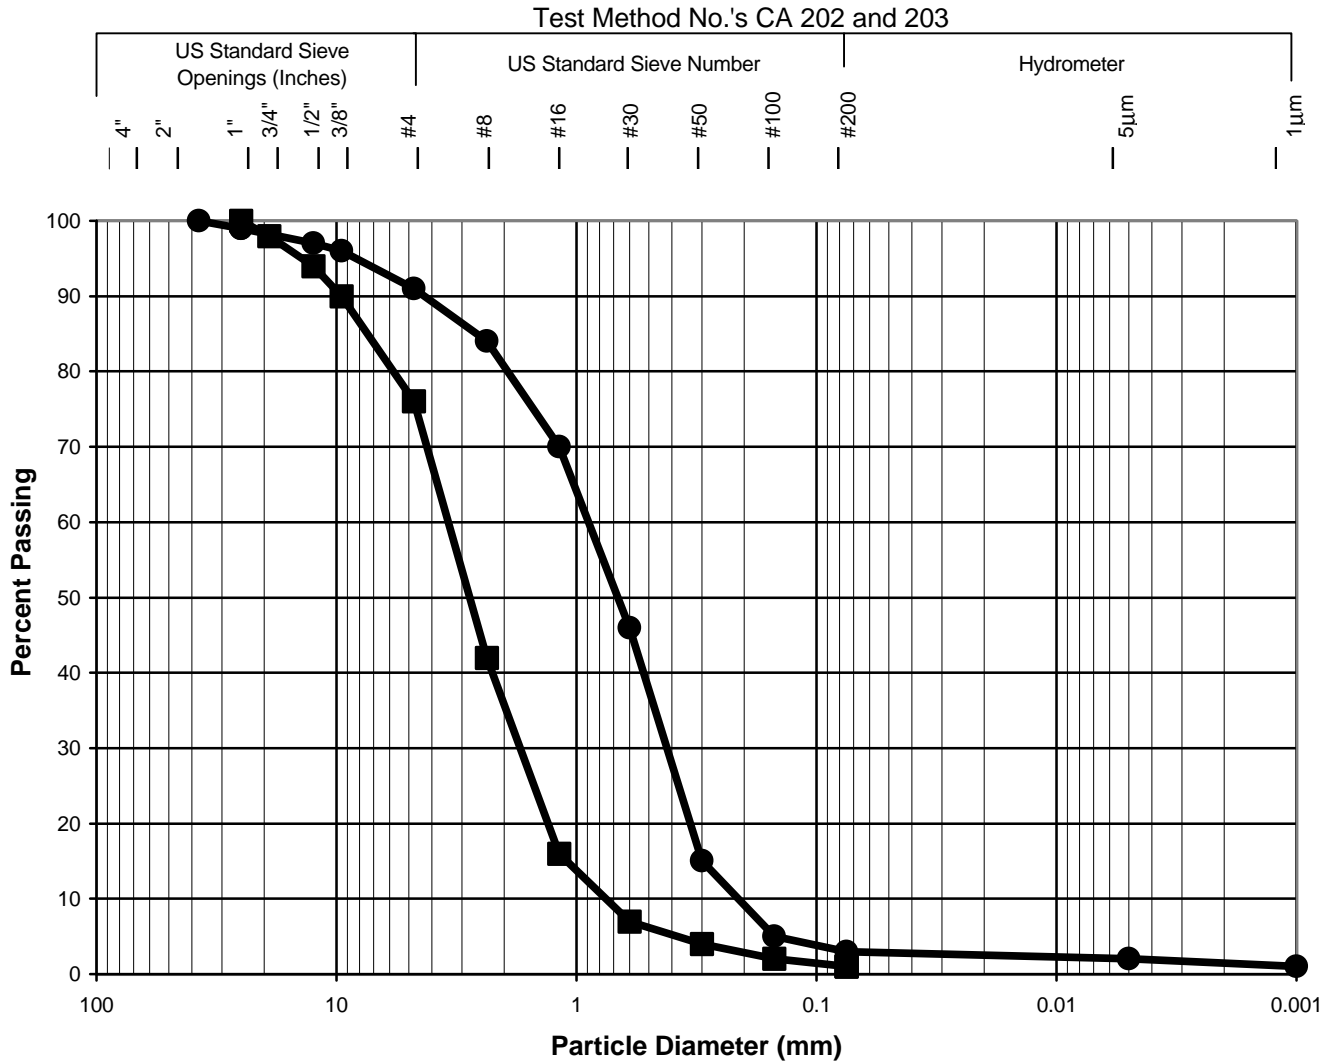
**Sample ID:** ● Site 11. channel bottom soil at upstream check dam in Cholame Creek  
 ■ Site 7. beach sand in intertidal zone of Pacific Ocean near Alder Creek

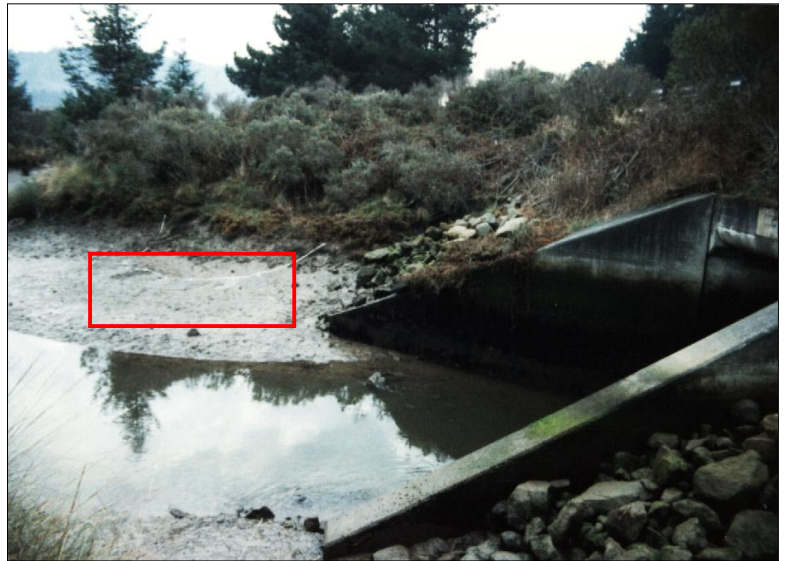
Photo 5. Before collecting test panels at low tide on 3 Dec 1992. Looking landward, a tidal gate (not visible) around channel bend at right, prevents saltwater from flooding pasture lands, while storm runoff can pass through gate into the slough. Tidal currents reverse direction twice daily, so for incoming tides, the far bank becomes the inside of channel bend. Just beyond panels, there is a relatively short length of dark area (arrow), and it is not shadows of vegetation, but shadows of cobbles and gravels, where very fine soil particles were removed by higher shear stress, typical on insides of bends. The other high shear stress zone is longer, and it is on the near bank along the outside of bend for incoming tides, evident by larger rocks protruding on bank.

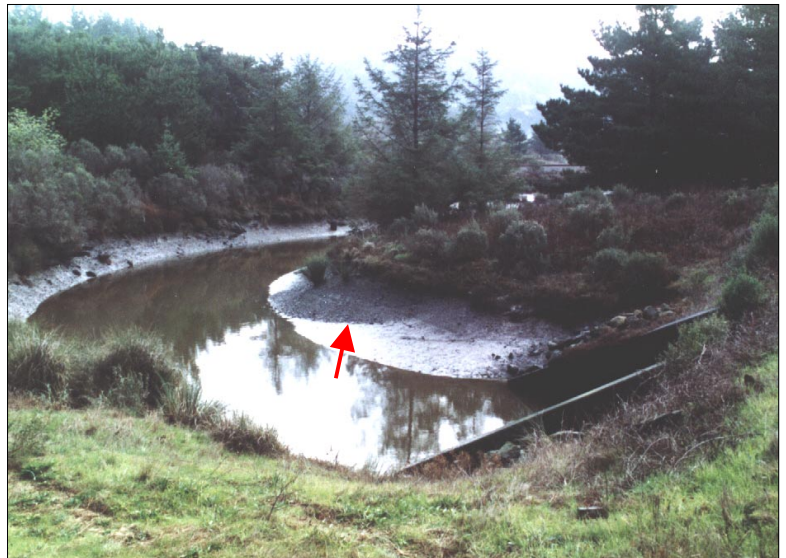
Photo 6. After collecting panels at low tide on 3 Dec 1992, 2.85 years of exposure. Panel prints on muddy side slope indicate about half or more of each panel was buried by an inch or two of naturally deposited fine-grained soil (bay mud). Upper parts of panels near top of slope were in direct contact with water, and corrosion compounds eroded by rising and falling water levels, relatively low velocities (5 fps and less), and wind-driven surface ripples. In the low shear stress zone, mud deposited and shielded most of each panel from erosion by tides, while corrosion continued. Also see photos 7 through 13 and captions. Cobbles and gravels pointed out in photo 5 are right of right-most panel print.

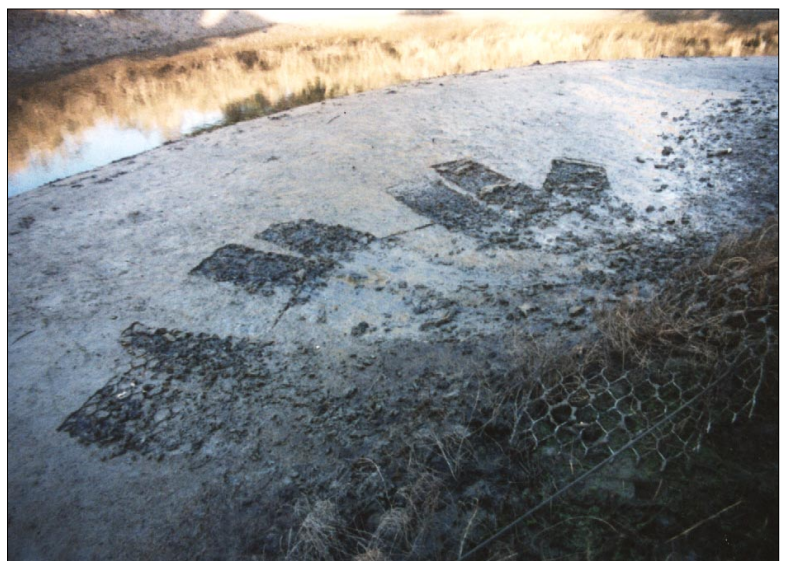
Test panels from Site 1 White Slough 01-HUM-101 post mile 70 northbound 3 Dec 1992  
Bay mud was gently washed off.  
Background is clean, washed concrete.

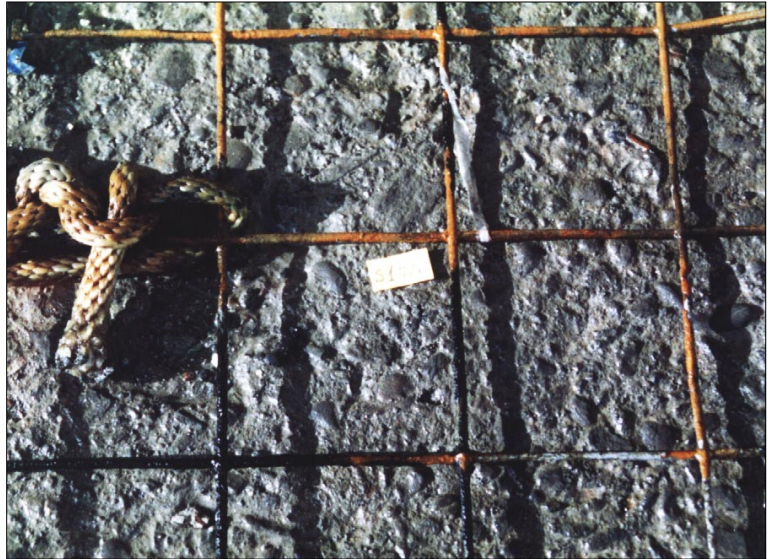
Photo 8. Product 4 (zinc-coated mesh) after 2.85 years. Upper zone of test panels near top of slope. Product 6 was similar.

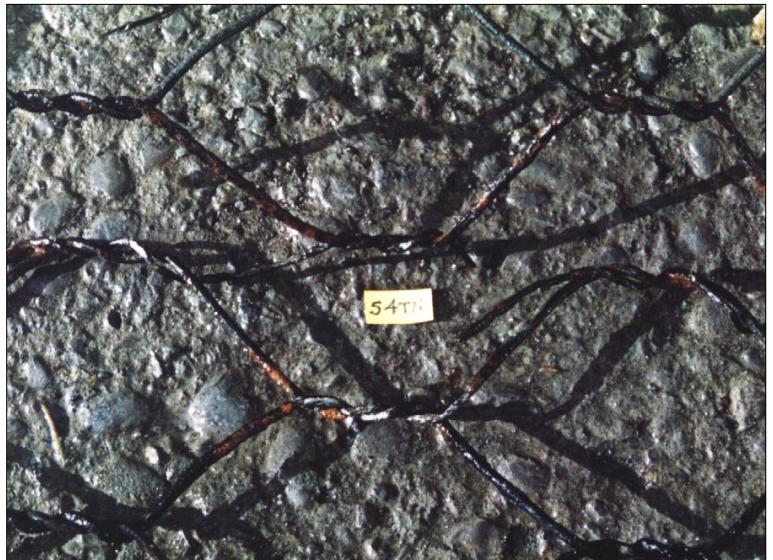
Photo 9. Product 5 (PVC-coated mesh) after 2.85 years. Upper zone of test panels near top of slope. Products 3 and 7 were similar.

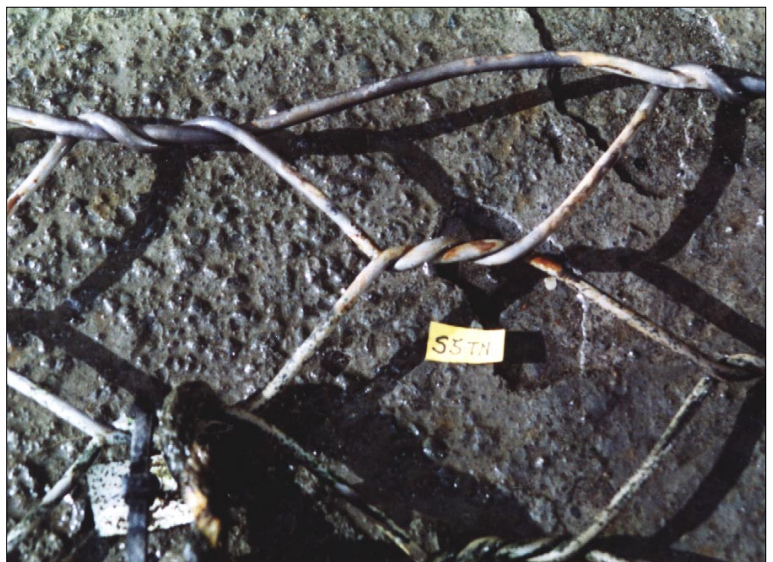
PVC discolored from bay mud. Normal daily cycle of temperature change causes PVC to disbond from underlying wire (also seen and documented in lab study). At any cuts and breaks in PVC, electrolyte entered capillary space between wire and PVC, and corrosion proceeded. Corrosion compounds near cut ends of mesh were shielded by PVC and did not erode by tides like the zinc-coated wires.

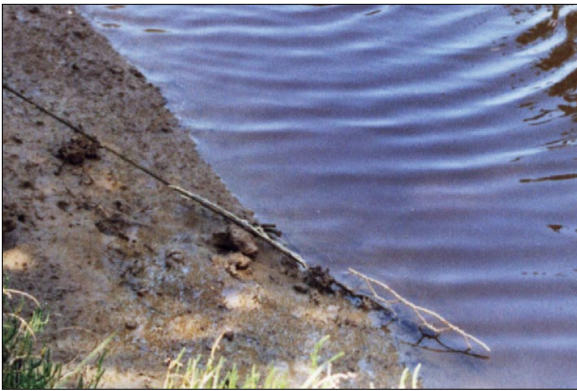
Photo 10 (top left image). Tidewater level changes, mild currents, and wind-driven surface ripples provided enough energy to erode tops of zinc-coated test panels that protruded above naturally-deposited bay mud. Site 1 White Slough 01-Hum-101 post mile 70 3 Dec 1992

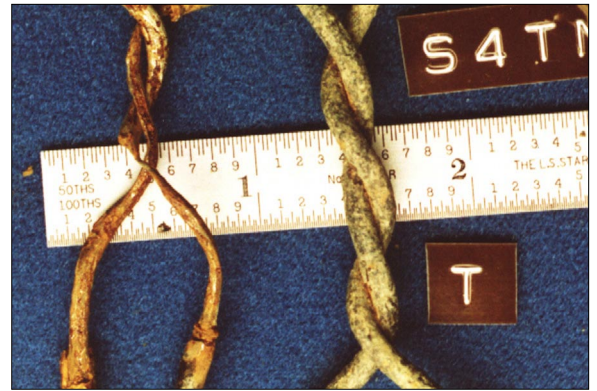
Photo 11 (top right image). Left wire pair of zinc-coated Product 4, twist very corroded and eroded by tides. Right wire pair corroded and shielded under 2" of bay mud and near initial diameter of 120 mils, after 2.85 years at Site 1. Product 6 was similar.

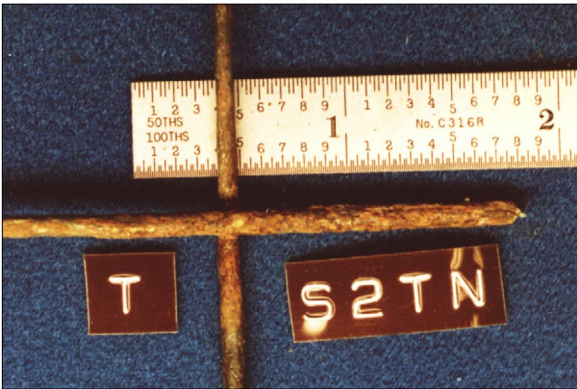
Photo 12 (middle left image). Product 2 zinc-coated welded wire corroded and eroded by tides. Initial diameter of 148 mils was less than 100 mils after 2.85 years at Site 1. Product 1 was similar.

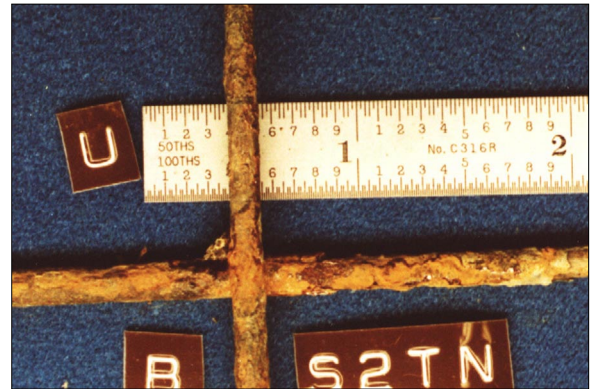
Photo 13 (middle right image). Corroded wires of Product 2 shielded by bay mud, similar to right wire pair in photo 11, near (and larger than) initial diameter of 148 mils, after 2.85 years at Site 1. Product 1 was similar.

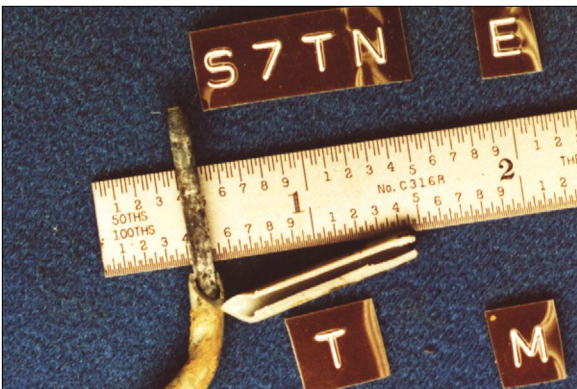
Photo 14 (bottom left image). Product 7 PVC disbonded from wire due to daily temperature changes, regardless of how PVC was bonded to wire. At cut edges of panels, electrolyte migrated into capillary space between PVC and wire. Site 1 after 2.85 years, white and gray corrosion compounds, early state of corrosion. Products 3 and 5 were similar.

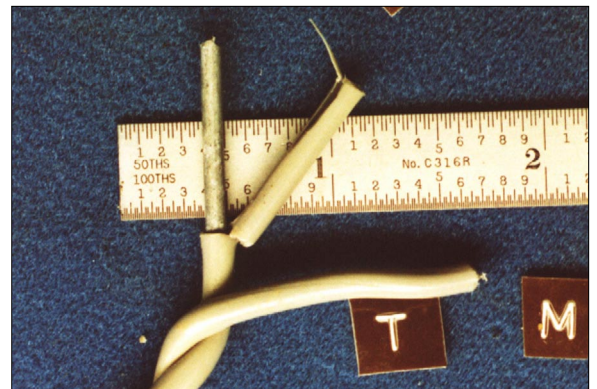
Photo 15 (bottom right image). Product 7 Very little corrosion after 2.85 years at Site 1, PVC disbonded as in photo 14, however, this wire pair was about 8" from cut edge. Products 3 and 5 were similar.

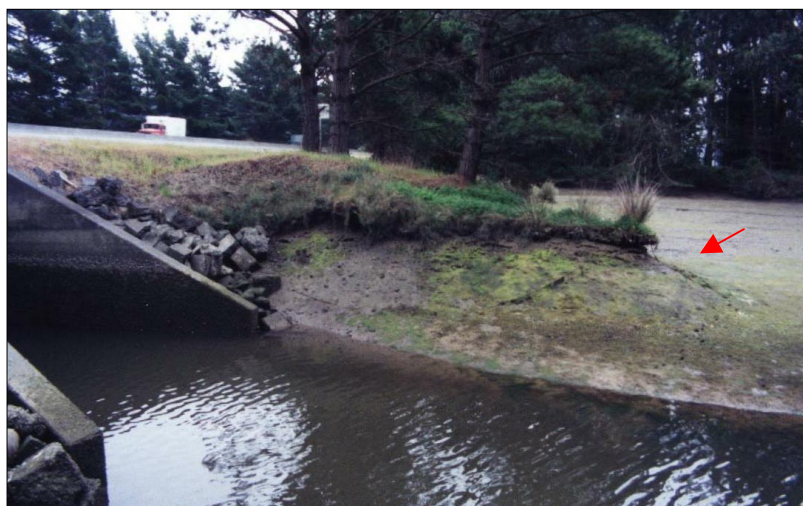
Photo 18. Collecting test panels while standing  
on 1" x 6" boards to avoid sinking in bay mud.

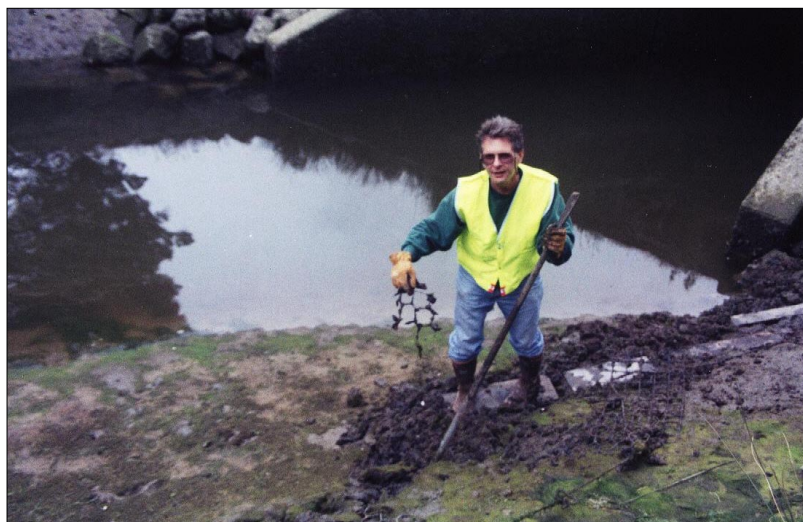
Zinc-coated test panels were more than 50% disintegrated, even after very careful excavation, we were able to collect only portions of zinc-coated panels and the Al-coated panel, because of their advanced states of corrosion. 100% of PVC-coated test panels of product 3, 5, and 7 were collected. See photos 19 through 24.

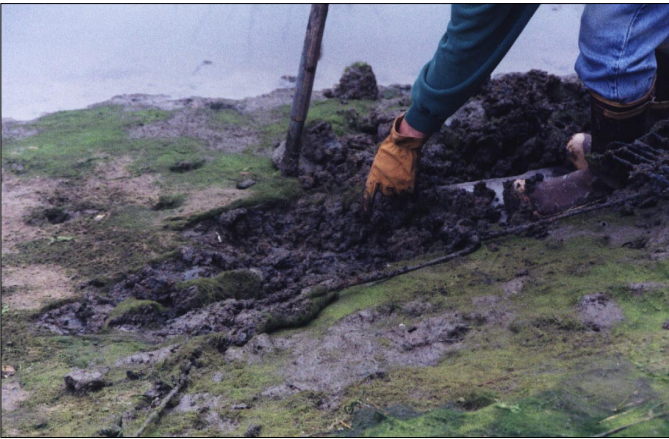
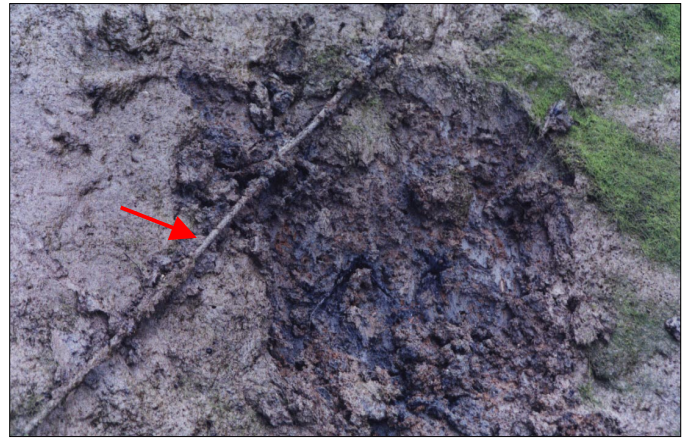
Photo 19 (top left image). Collecting a remnant of zinc-coated gabion test panel that did not disintegrate.

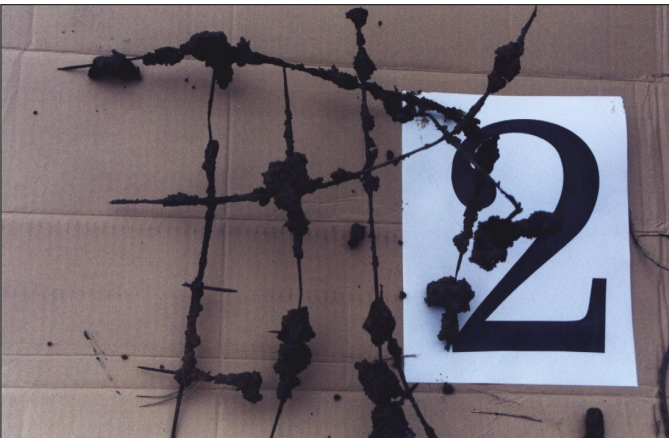
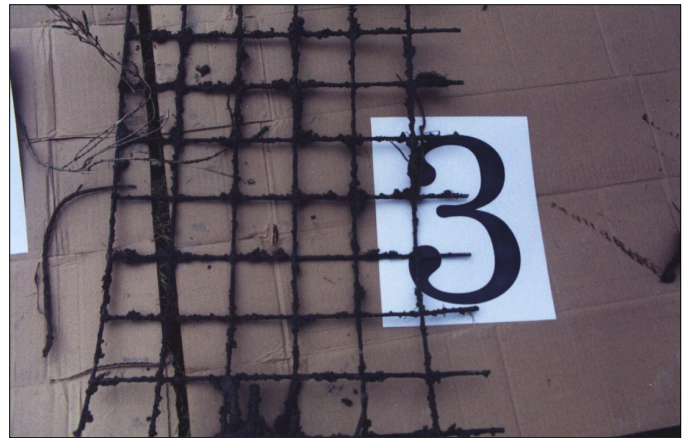
Photo 21 (middle left image) remnant of product 2, zinc-coated welded wire, product 1 similar. Black numerals on white 8 1/2 " x 11" paper.

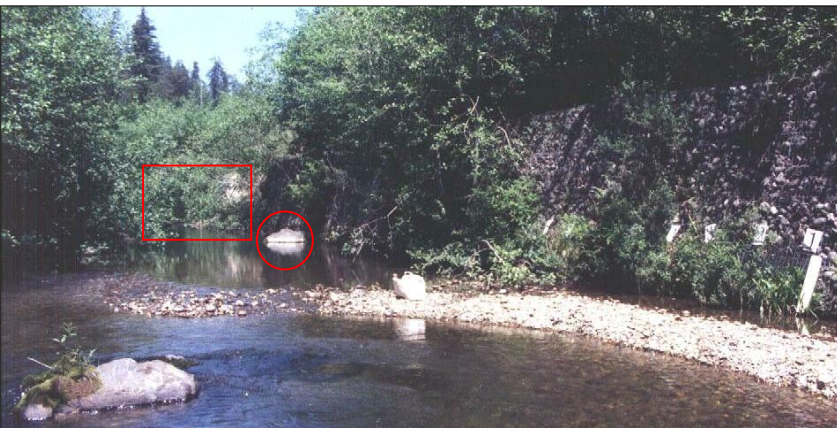
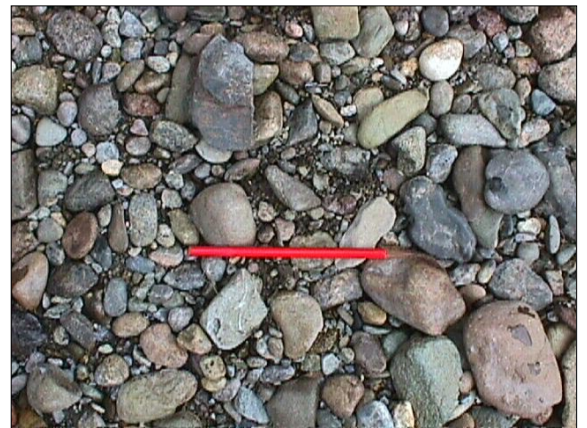
Photo 35. almost same view as photo 33, 9.5 years after installing test panels, 26 May 1999. 30" high scale (at right) on test panel of product 1 (8 1/2" x 11" white labels). Upstream of 1-ton rock (circle), earth and geotextile are exposed (box), 50-foot section of wall failed by corrosion. Canvas bag on gravel bar.

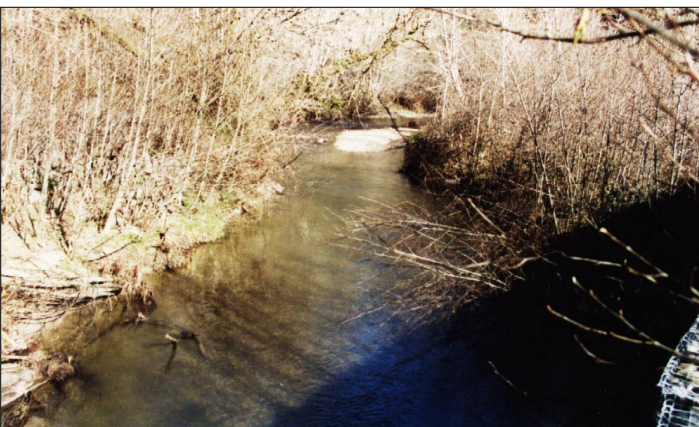
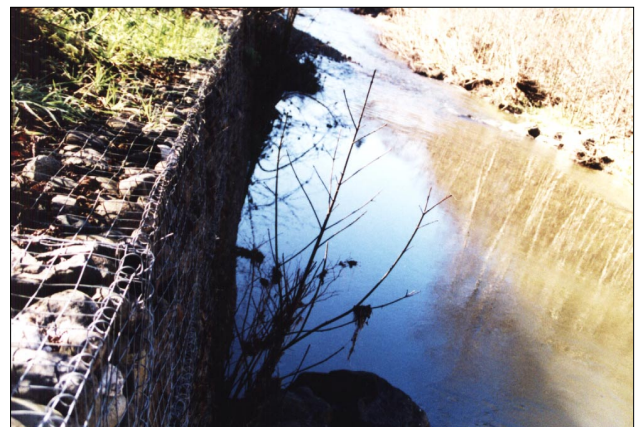
Photo 37 (left image). looking upstream at reach of creek that impinges on wall, 14 Feb 1996. Alders (left side of image) bent nearly horizontal indicate recent high velocity event.

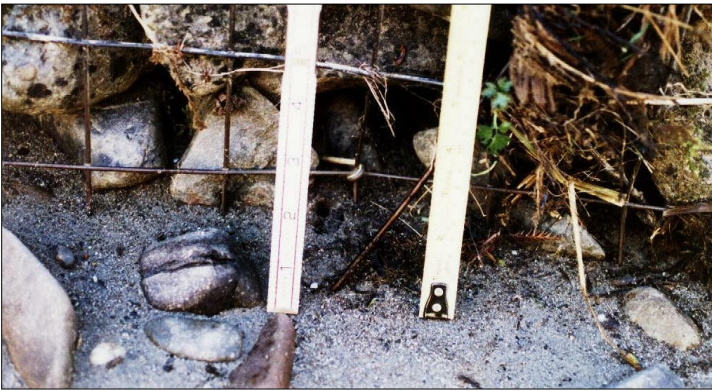
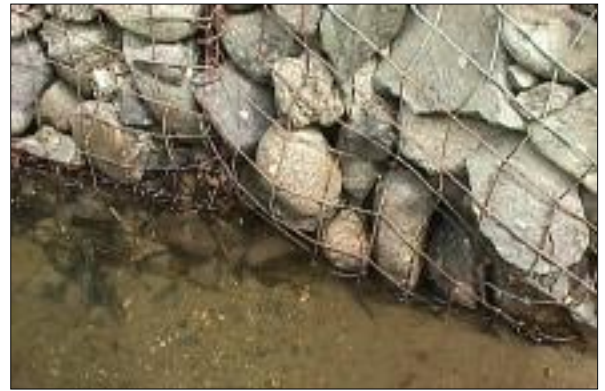
Photo 39 (left image). wall at creek bed elevation, just upstream of wall, 14 Feb 1996. This zone protected by 1-ton riprap, not directly impinged-on by creek, rust on lower wires, white corrosion compounds on upper wires.

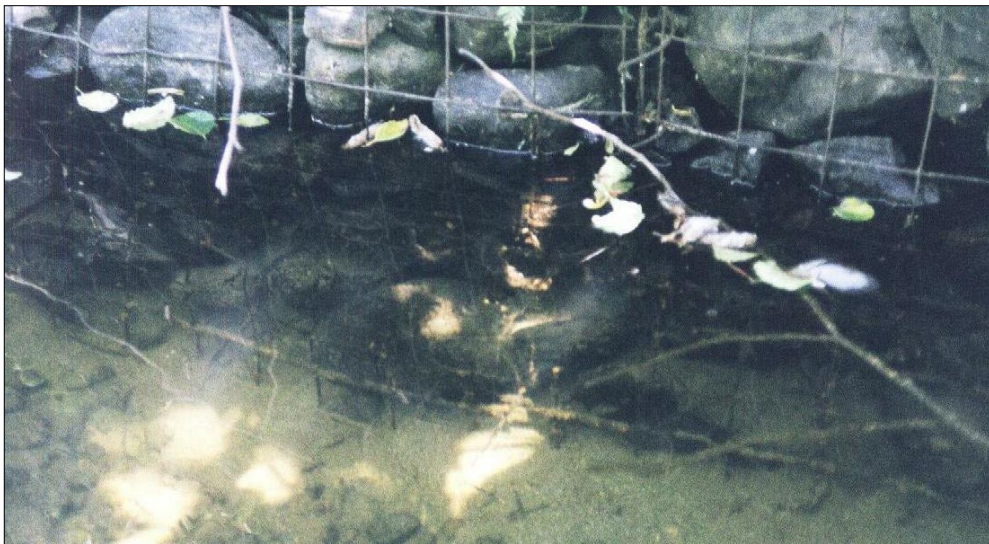
Photo 41. looking under 1 foot of water in scour zone, 50 feet downstream of failed wall, 15 feet upstream of test panels, 26 May 1999. Rusted wires corroded, some disintegrated (center, under water), rock-fill is no longer confined. Creek bed particle sizes range from fine sub-angular sand to 3-inch rounded gravel.

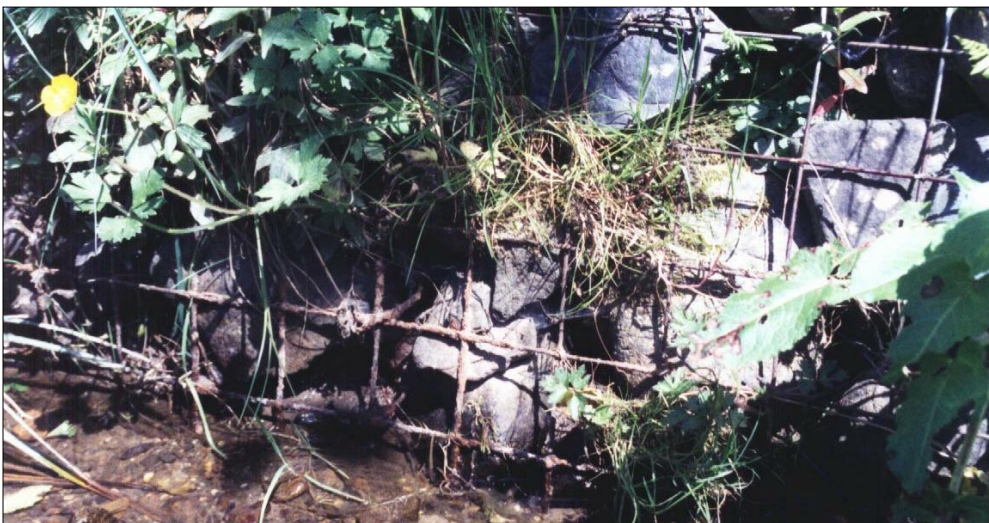
Photo 42. creek bed and wall under test panels, 26 May 1999. most bedload and high-velocity suspended sediment did not get here. Rust on low wires, no rust above ordinary high water, 1-foot above creek bed.

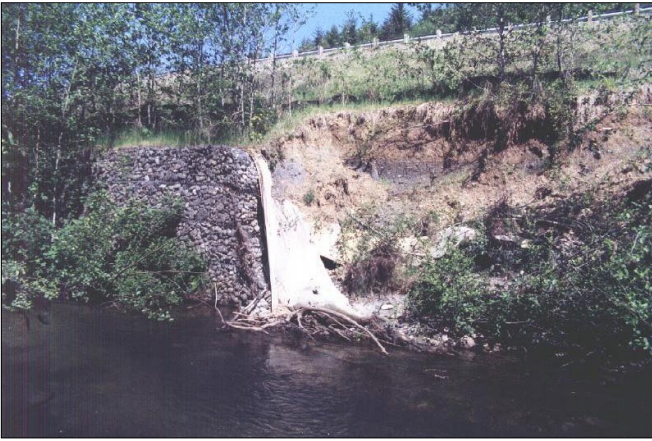
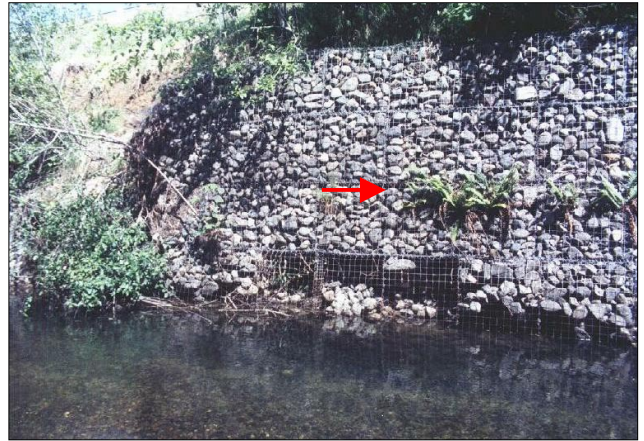
Photo 43 (left image). failed gabion wall in impinging zone of creek. Wires corroded and disintegrated, rock-fill emptied, then 50-foot section of wall collapsed during January 1997 storms. Riprap protected end of wall from abrasion, however, not from corrosion and possible future failure by continued corrosion. See Photo 49.

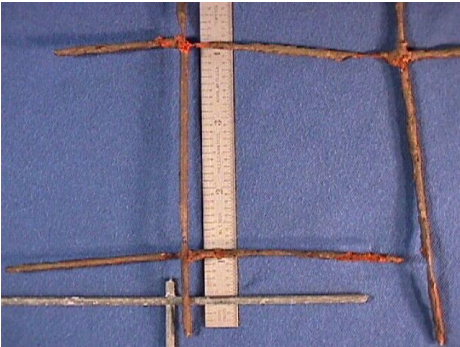
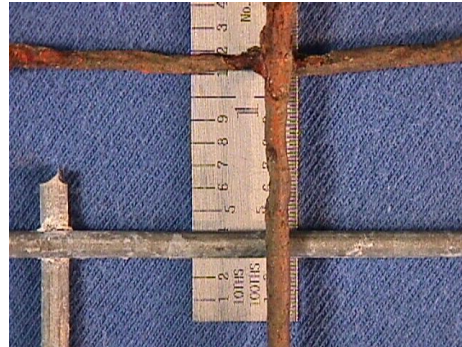
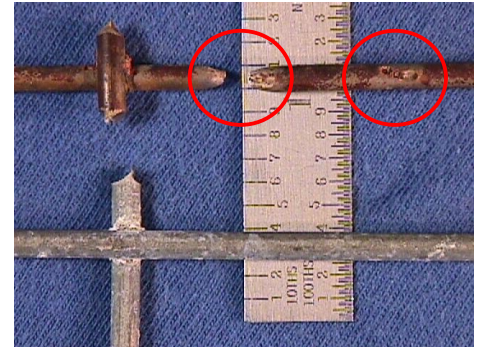
Photo 45 (middle left image). abraded corrosion compounds eroded by flowing water after 11 wet seasons.

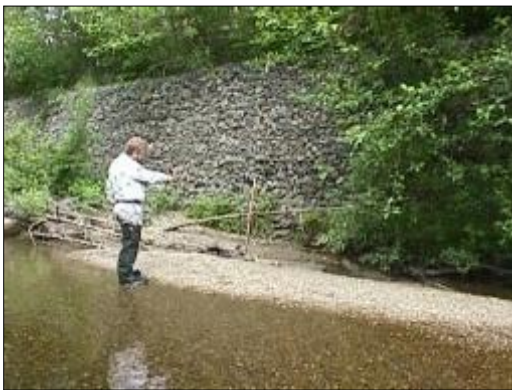
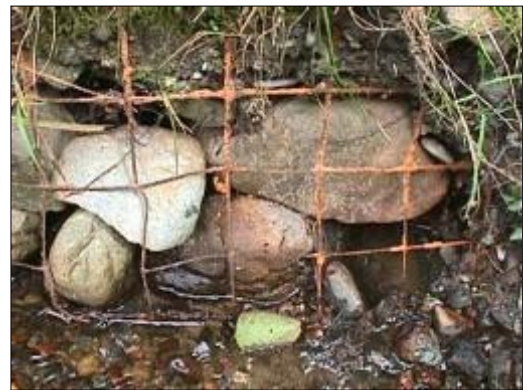
Photo 48 (left image). observer pointing out aggraded zone, about 200 feet downstream of collapsed 50-foot section of wall. About  $\frac{3}{4}$  of wall along its length still had rock in bottom and 2<sup>nd</sup> tier of wall. 27 May 1999.

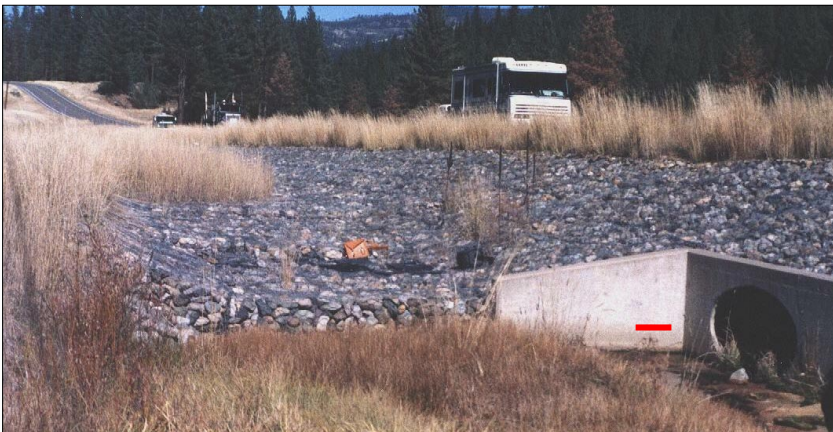
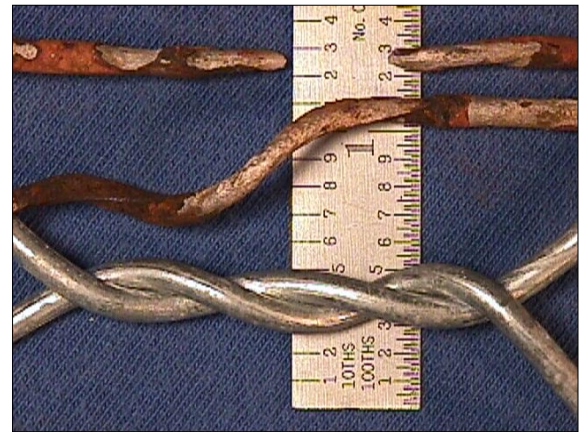
Photo 61 (left image). After collecting wire samples from 8 products, remainder of panels were left in place, 20 Oct 1998. Water ponded 1-foot or higher, as indicted by stain on 36-inch culvert wingwall (line). Mattress of inlet invert apron submerged in stagnant water, > 50 percent silted-in, almost completely covered with vegetation. Water measurements showed low dissolved oxygen, prolonged stagnant water. Sag in road (at left, about 500 feet away) is where Mohawk Creek is conveyed under road. See photos 63 and 64.

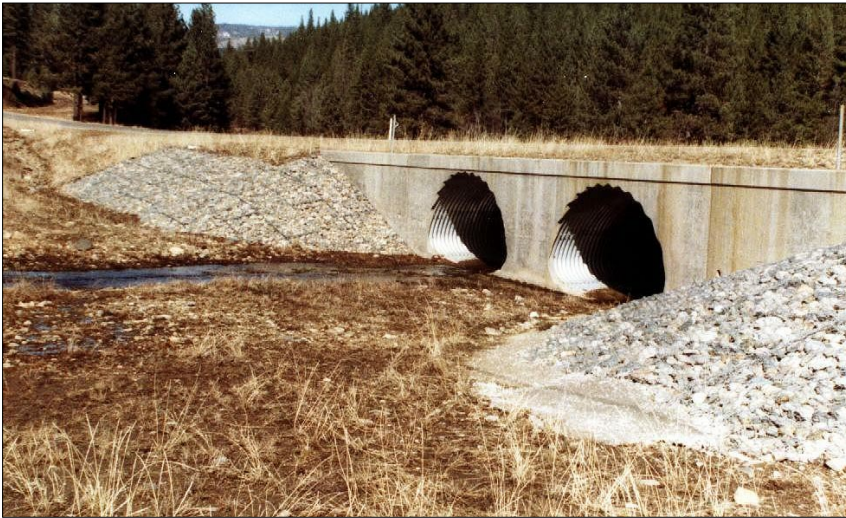
Photo 63. Inlet of double 10'-11" wide x 7'-1" high structural steel plate arch culverts which convey Mohawk Creek under route 89. Flow is continual in normal water-years. Culverts and gabion mattress slope protection, 1½ years after construction, 6 Feb 1991. At toes of slopes, gabion counterforts (3' x 3' cross section) were concreted during construction. Toe at creek has 27-foot plan view radius (left, far side) and 40-foot radius (right, near side). Counterforts built 3-feet below culvert invert elevation for possible local scour.

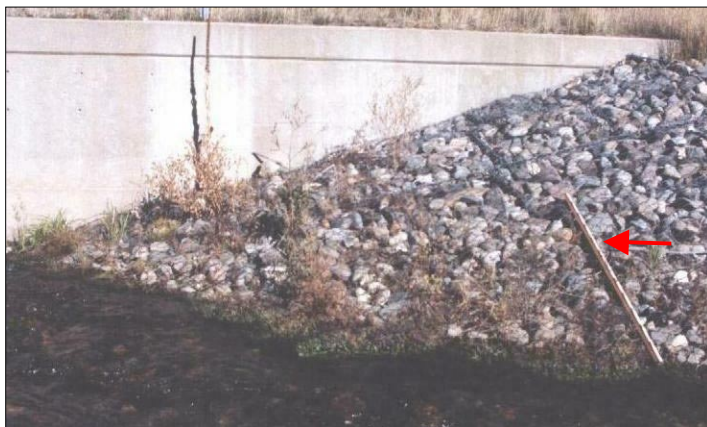
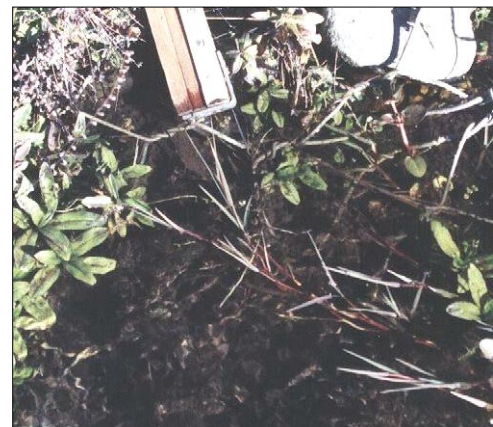
Photo 65 (left image). Gabion-protected slope on right side of culvert inlet, 20 Oct 1998. Sparse vegetation in baskets indicates prior high water, about 4-feet from toe along slope line (6-foot long rod, arrow).

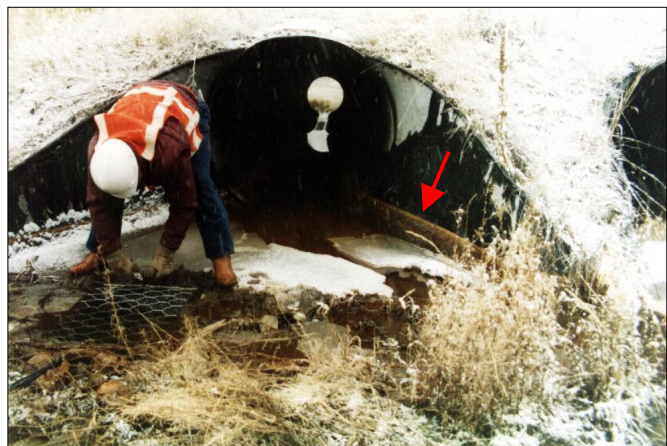
Photo 70 (right image). Fastening product 8 test panel to dissipater near culvert outlet, 3 years after products 1 through 7 were placed, 2 Dec 1992. Rust stain (arrow) on flared end section at right, indicates normal high water. As snow melts in late spring, water level rises, submerging all of dissipater.

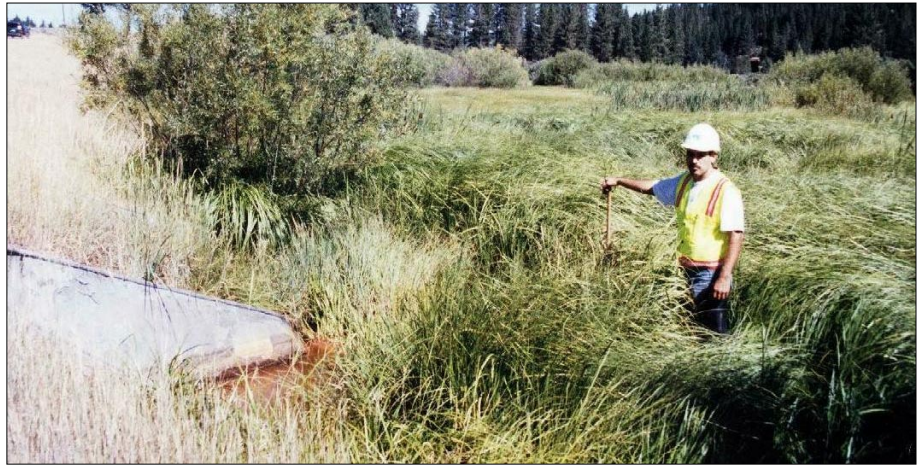
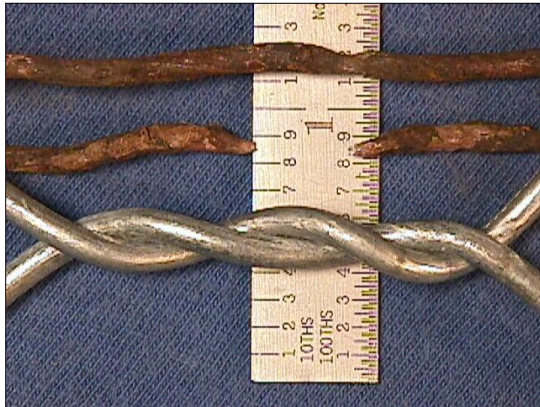
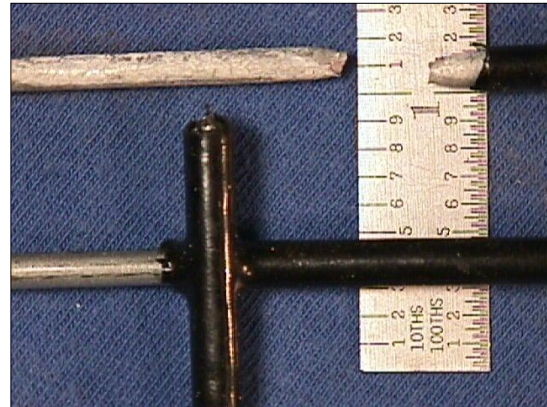
Photo 72 (left image). 2 upper wires are product 4 test panel wires (dissipater made from product 4), typical of zinc-coated wires submerged about 10 years, contrast to (bottom) control wire pair. Middle wire tensile-tested, broke in twisted zone. Top wire is other half of twisted pair, lost cross-sectional area in twisted zone due to corrosion. Product 6 similar. Energy dissipater wires felt very similar to products 4 and 6.
