# GABION MESH CORROSION

## Field Study of Test Panels and Full-scale Facilities

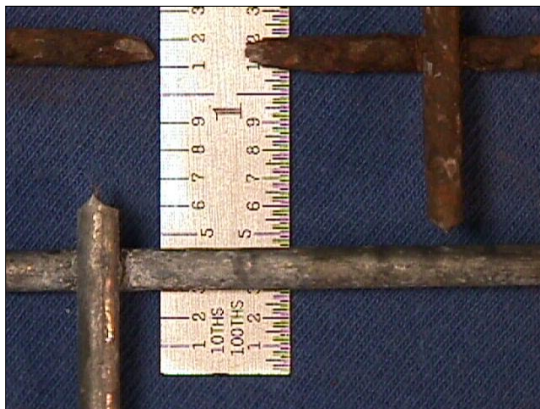
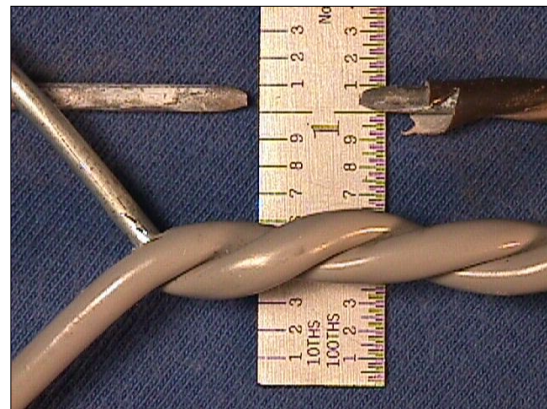
Photo 74 (left image). Product 2 test panel wire (top) after 10 wet seasons, tensile-tested, (bottom) control wire. Product 1 similar.

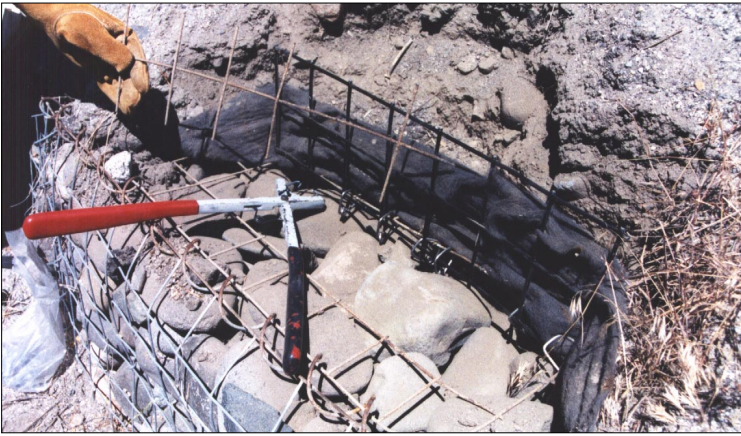
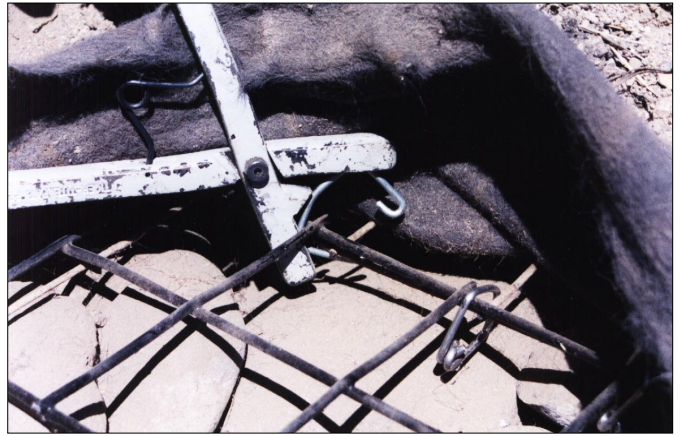
Photo 79 (left image). Collected sample of lid panel (product 1), 4 Aug 1999. Removed soil, lifted nonwoven RSP-fabric, cut-out 18" x 6" sample (in hand), repaired cut-out with product 3 (black PVC-coated mesh).

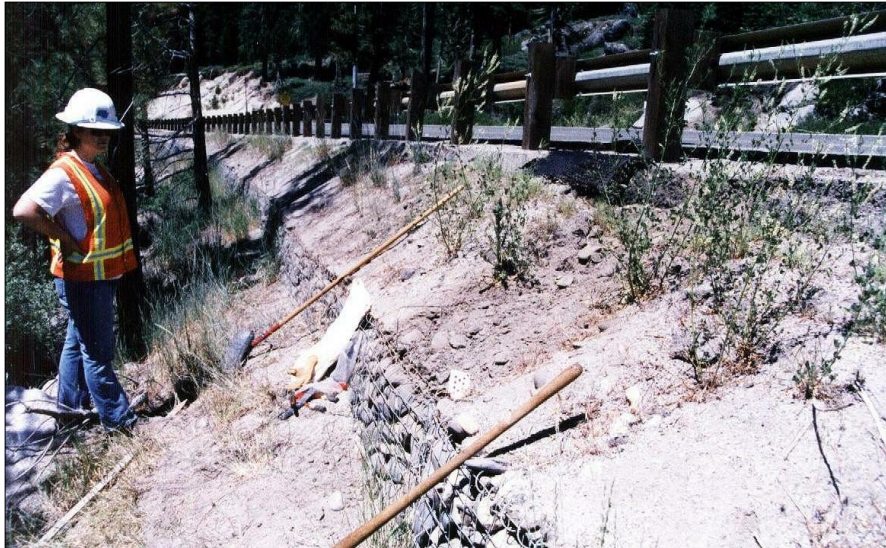
Photo 81. Replaced RSP-fabric then restored slope, 4 Aug 1999.

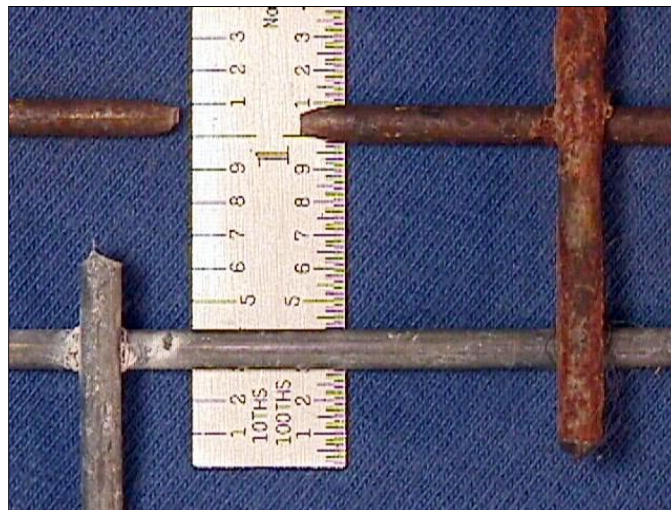
Photo 82. Top wire tensile-tested, from lid panel, contrasted to control wire (bottom). Large (28 percent) strength gain, likely due to larger diameter lid wires, strain aging, relatively small sample ( $n = 38$  wires) to calculate coefficient of variation, and different heat (batch) of steel.

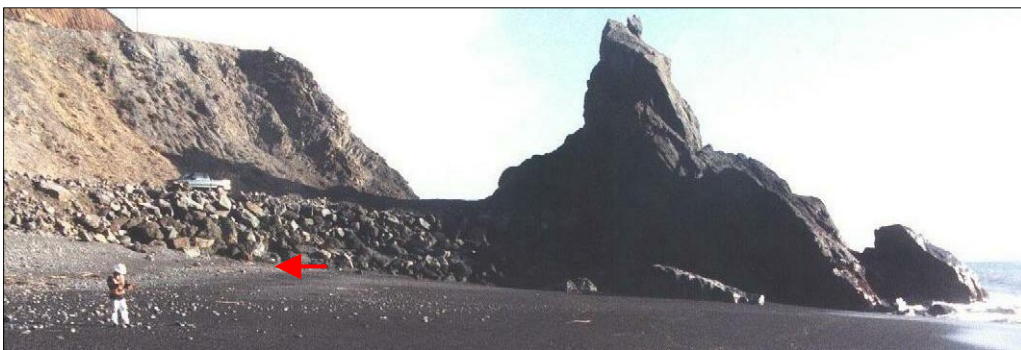
Photo 86. North RSP and gabion mattress mostly OK after 13 wet seasons, 4 Nov 1998, looking southerly. Waves reached higher than elevation 25 feet in January 1997 storm that caused Duck Pond slide (about 1 mile northerly), beach received about 10 feet of sediment, eroded and stabilized after 3 days. Beach cycles between scour and accretion, shown here with about 6 feet of accretion (left of arrow).

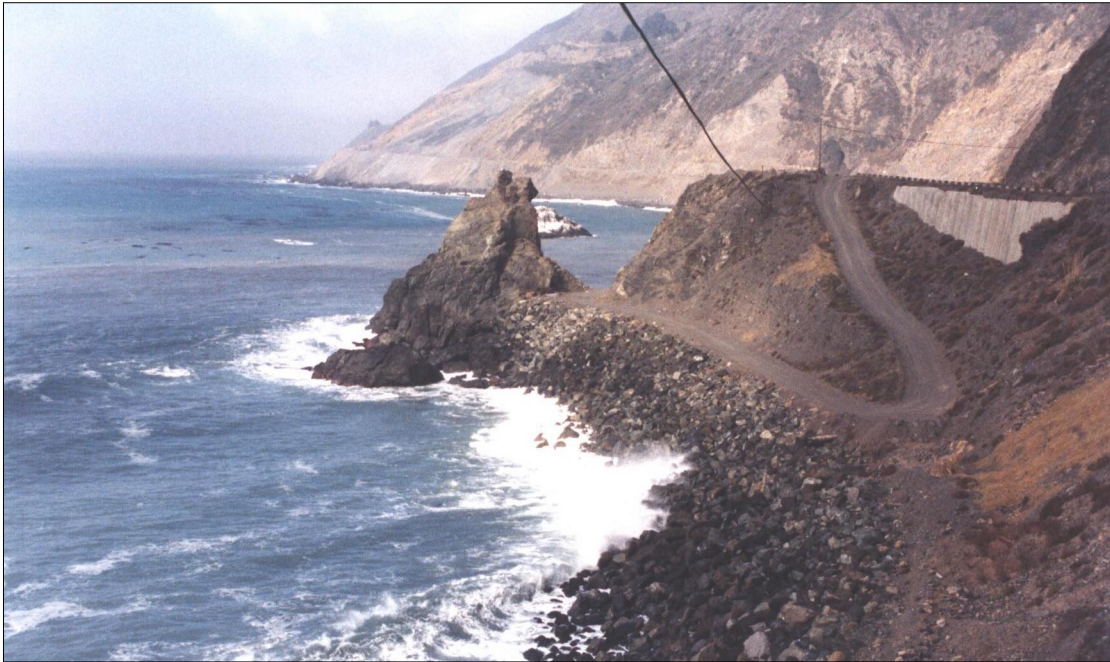
Photo 87. Normal high tide, waves break directly on south RSP, a deepwater revetment, looking northerly, mostly OK after 13 wet seasons, 4 Nov 1998. Nearly same cross-section as north RSP, except toe of PVC-coated gabion mattresses are at elevation 10 feet, 8-ton rock toe extends below mattresses. Duck Pond slide (Jan 1997) is bare land feature in far left background on point, more than 1 mile distant. Access to north RSP down steep grade from route 1, through rock cut, then to right.

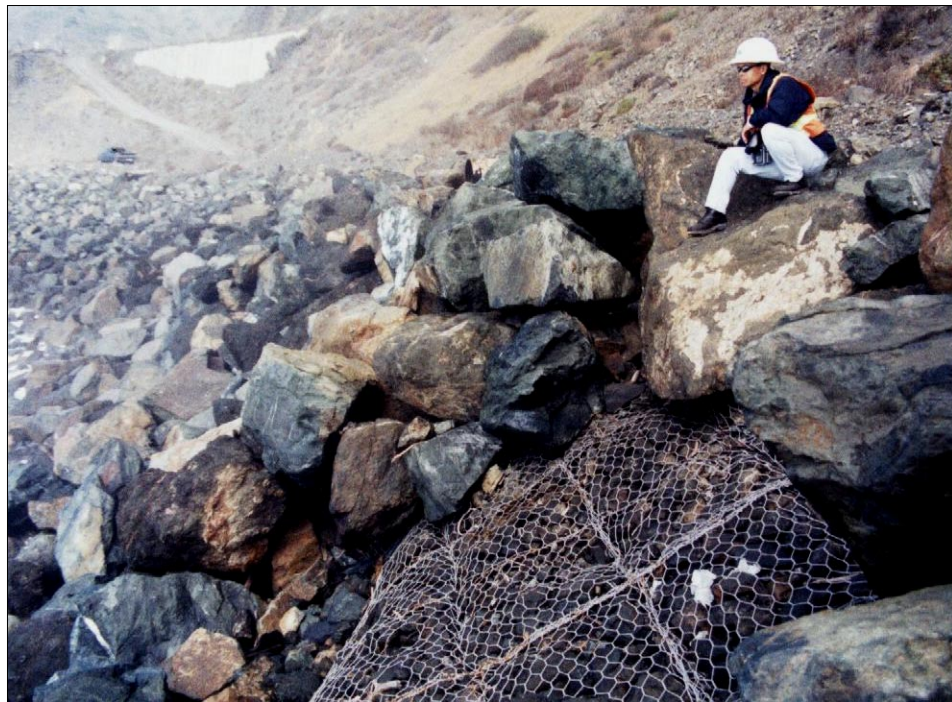
Photo 88. South RSP, looking northerly, rocks missing near top of revetment, some gabions exposed, 4 Nov 1998. Light rock displaced from lower part of revetment by above-normal waves of January 1997 storms, then rocks above the displaced lower rocks fell down slope, exposing mattresses. We saw one exposed zone among south RSP, while we saw several exposed zones among north RSP.

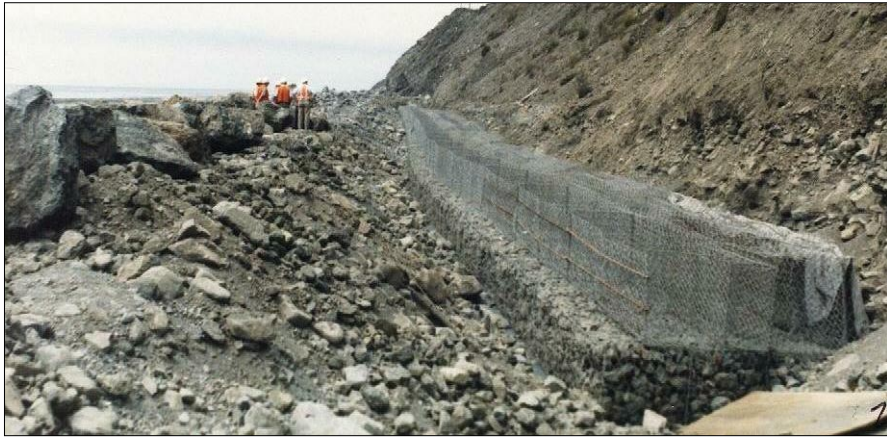
Photo 89. Building north wall with PVC-coated gabions, product 5, on 7 Aug 1985, looking northerly, near post mile 8.1. Base tier completed of 7-tiered, step-faced wall, bottom gabions at about elevation 4 feet.

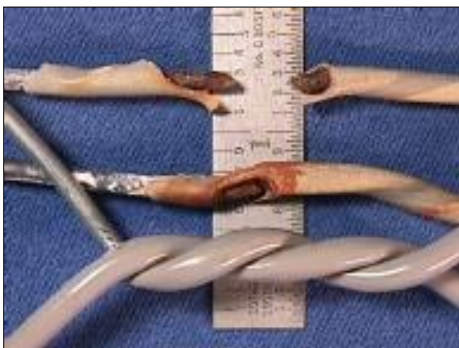
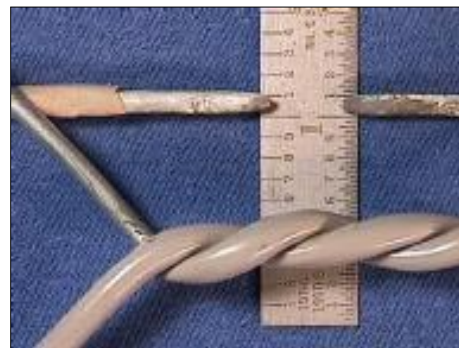
Photo 95 (left image). Blazed wire (top) represents damaged PVC, like wires impacted by rocks, see photos 97 and 98. Blazed wires lost about 35 % tensile strength after 13 wet seasons. Top and middle wires tensile-tested. All zinc at blaze was sacrificed, remaining zinc on wire was too far to offset local corrosion attack, where wire broke. Contrast left part of control wire pair (shiny, PVC stripped), to left part of middle wire (dull gray with white corrosion compounds, PVC stripped), where electrolyte got in space between PVC and wire.

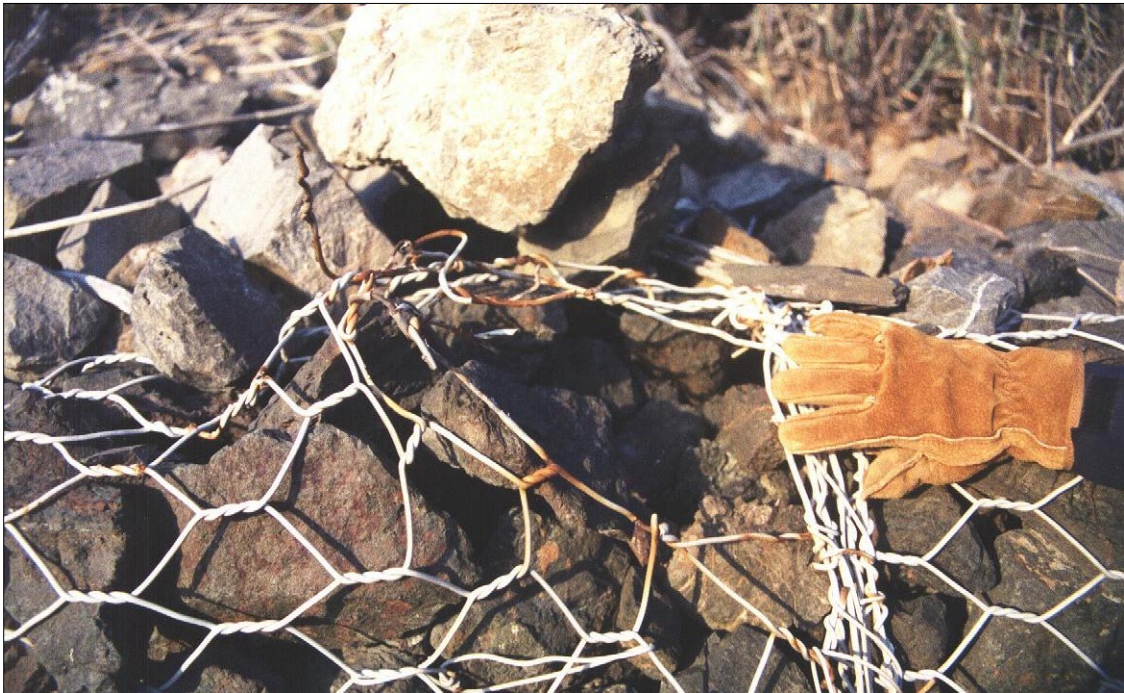
Photo 97. Corners and tread (horizontal portion) of stepped walls are intermittently impacted by rocks. Rocks slough from slopes above walls. Pacific Coast Highway is about elevation 60 feet. Top of wall is about elevation 25 feet, approximate reach of storm waves.

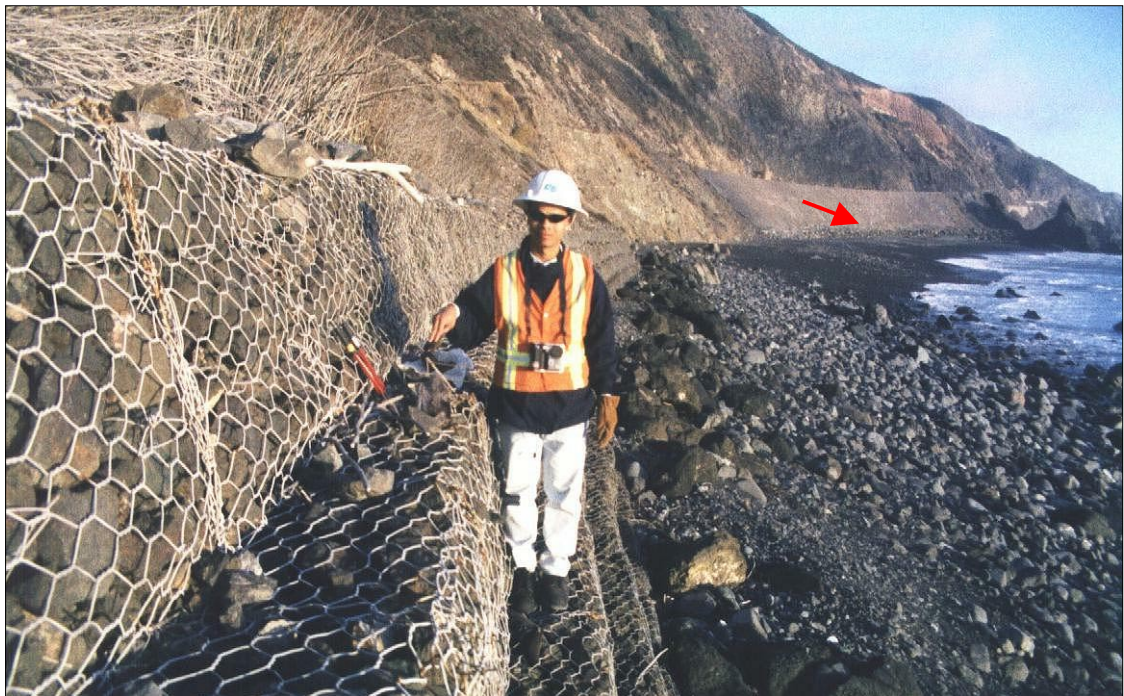
Photo 98. Observer points-out where sloughed rocks severed some gabion wires, gabion rock-fill is still contained. North RSP (arrow) is about ¼ mile distant. Both walls are OK after 16 wet seasons (assessed by maintenance, May 2001), despite broken wires from rock impacts.

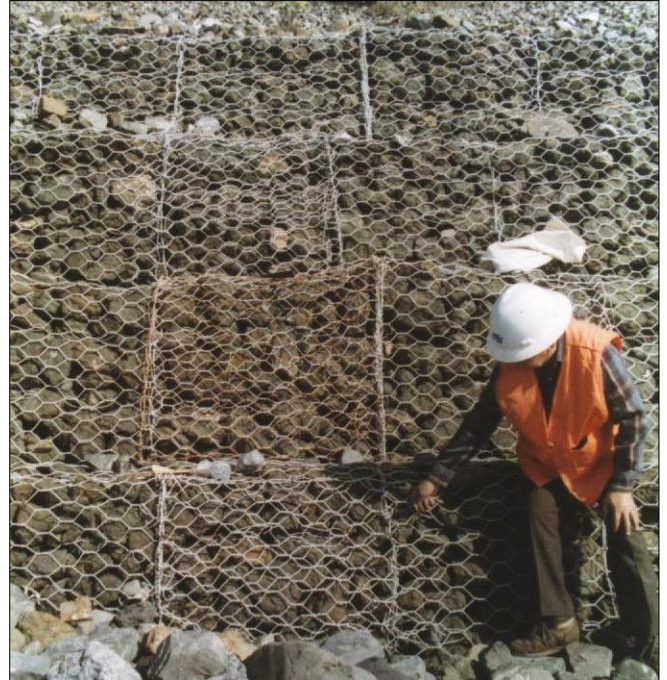
Photo 100.  
Tiger-tite™ interlocking fasteners.

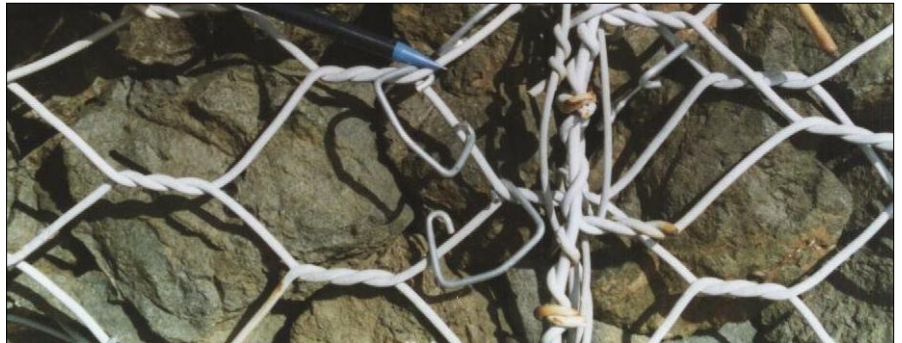
Photo 101. Zinc-coated (left) and stainless steel (right) Tiger-tite™ interlocking fasteners.

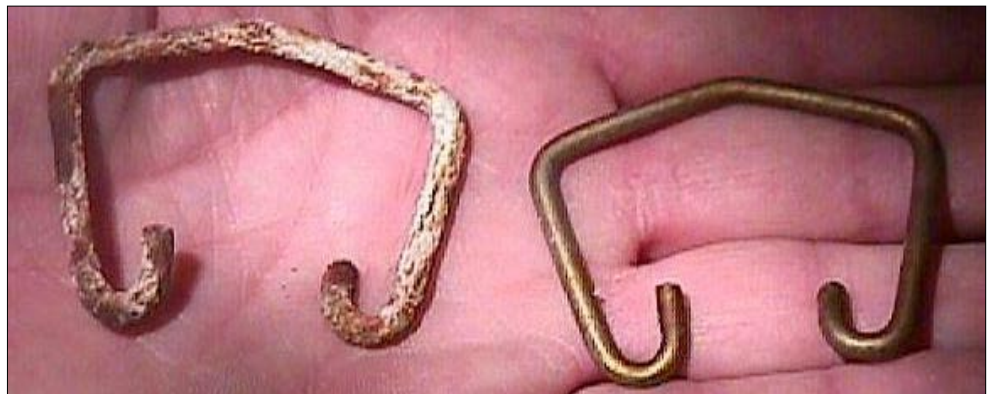
Nearly actual size, when printed as image on 8.5" x 11" page.

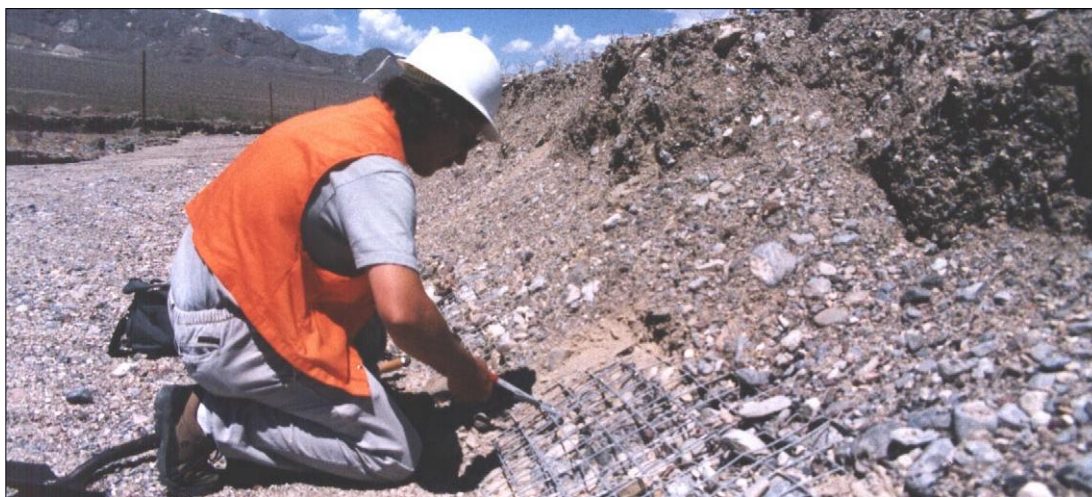
Photo 109. Repaired cut-out zone with interlocking fasteners and special long-handled pliers.

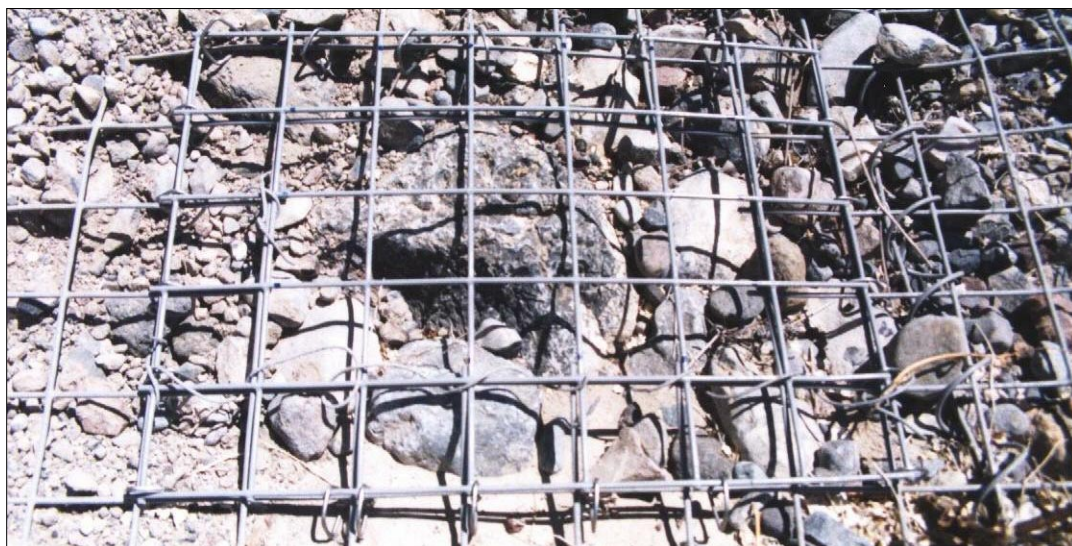
Photo 110. Completed repair. One stainless steel interlocking fastener placed in each mesh opening.

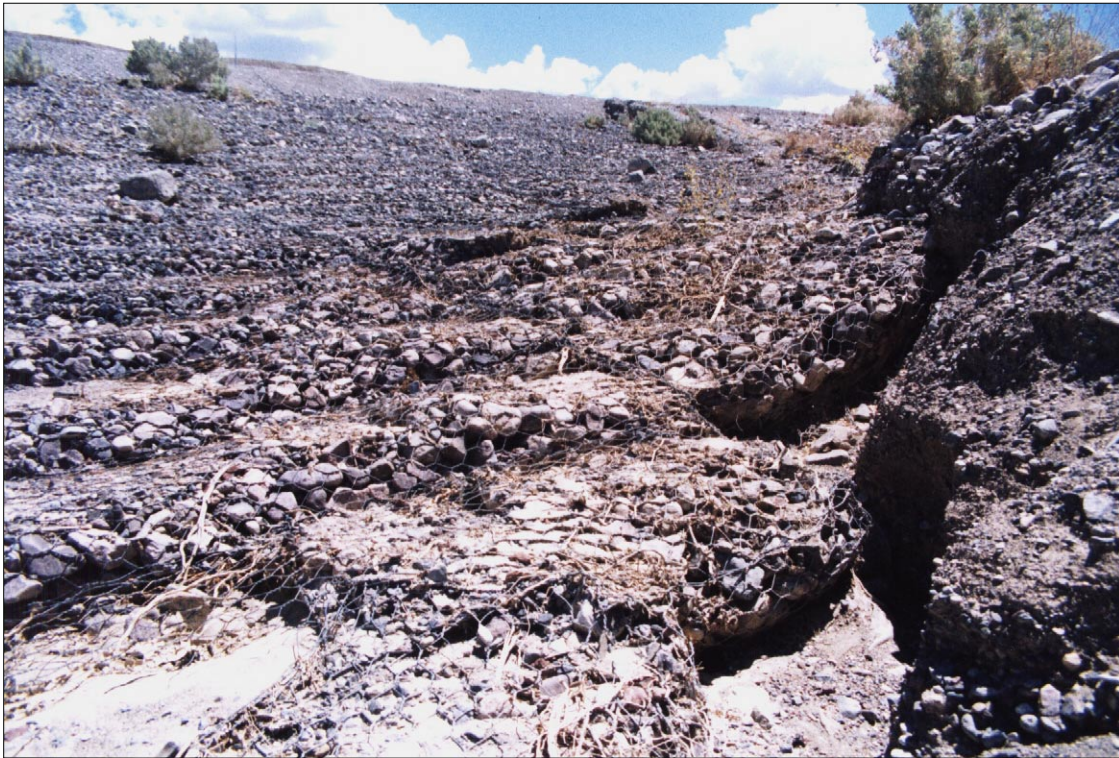
Photo 114. Gabion-protected slope is spillway-downdrain for flash floods, looking up-slope and upstream in Gower Wash (gully at right is seen on left in photo 112), 9 Jun 1998. Some lids failed due to abrasion by sand and gravel transported during floods. Brownish color is silt residue, and some rusted wires.

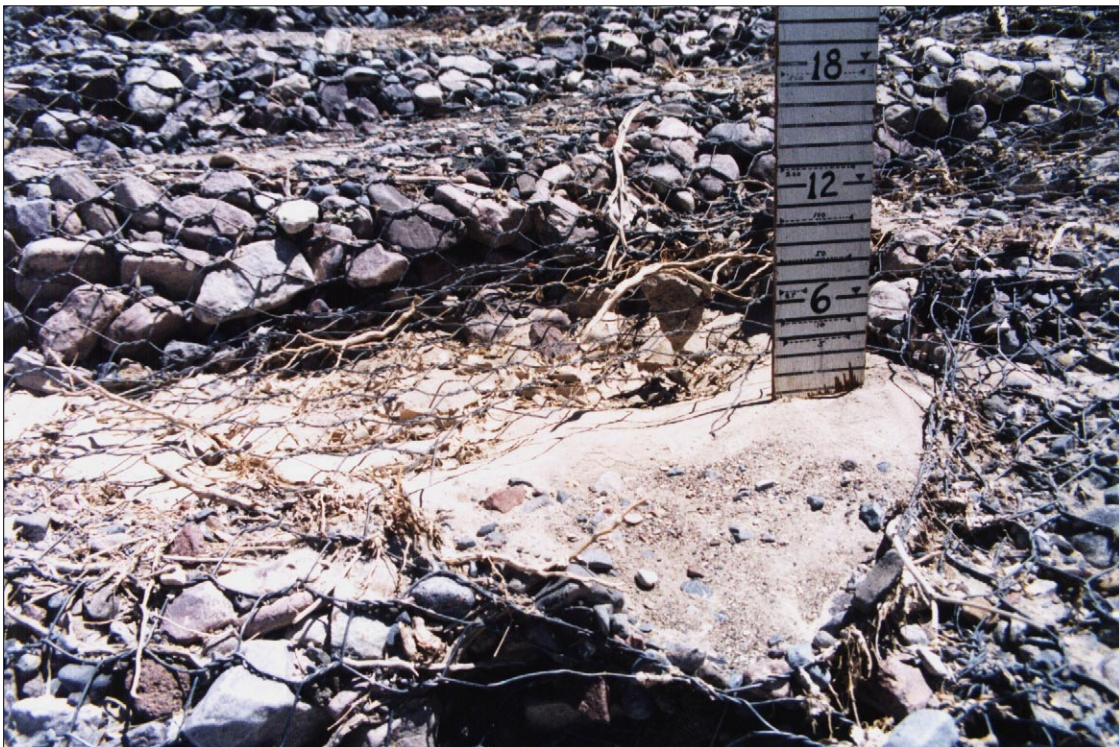
Photo 115. Collected wire samples from failed lid (failed basket seen at lower left in photo 114), 9 Jun 1998. Most wires still had some zinc (dull gray color, likely zinc carbonate), indicating low frequency of abrasive, flash floods. 30" high x 5" wide plywood scale is marked in inches.

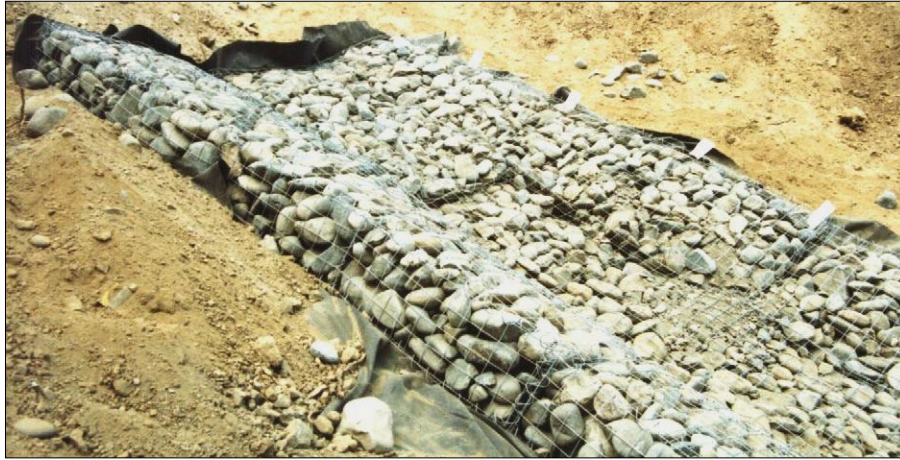
Photo 116. Building an open channel gabion downdrain, Sep 1987. First welded mesh gabion downdrain in Caltrans, made from product 1. Trapezoidal section, 1-foot high mattresses, 15H:1V side slopes, 3-foot wide bottom, woven filament geotextile underneath, 3' x 3' x 6' long counterforts every 43 feet. Longitudinal (downhill) slope is about 2H:1V. As with most culverts, installation proceeded from low to high elevation.

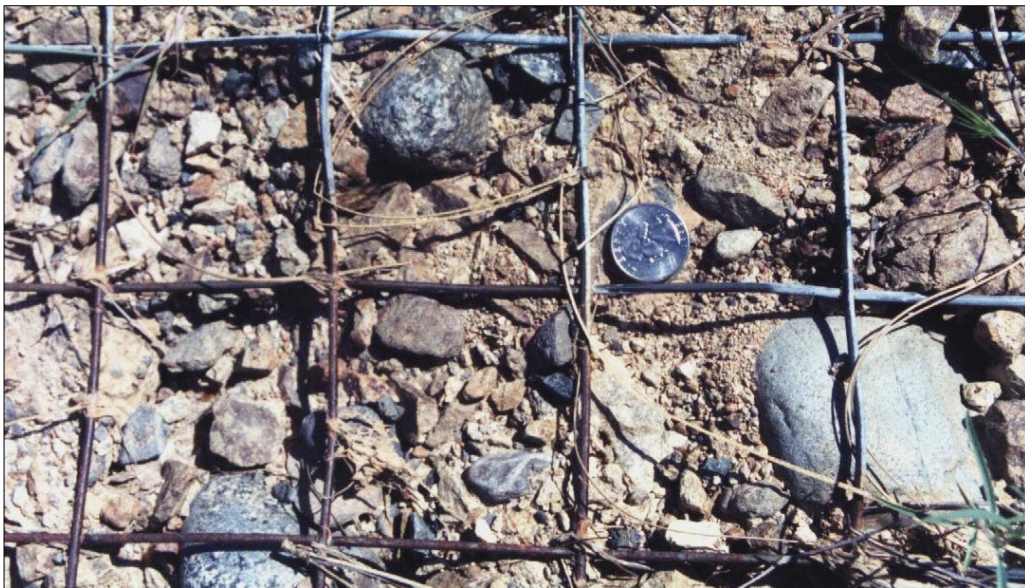
Photo 124. Rusted wire at edge of splash zone (downhill at top of photo), after 12 wet seasons, 28 May 1999. Zinc (dull gray, likely zinc carbonate) still present (by shiny quarter) indicates relatively little abrasion. Rusted wire diameters not significantly different than wires with zinc.

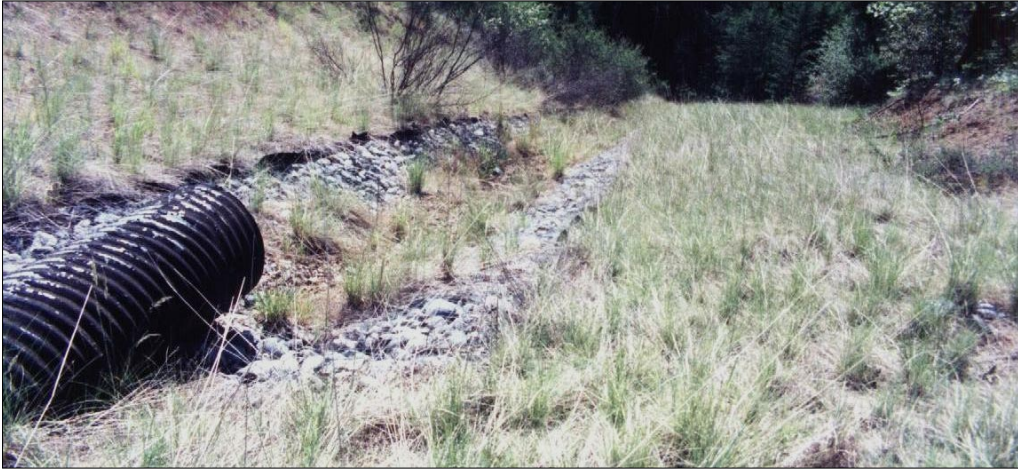
Photo 125. Sediment trapped in gabions continues to support vegetation. Gabions and slopes OK after 12 wet seasons, looking downhill, 28 May 1999.

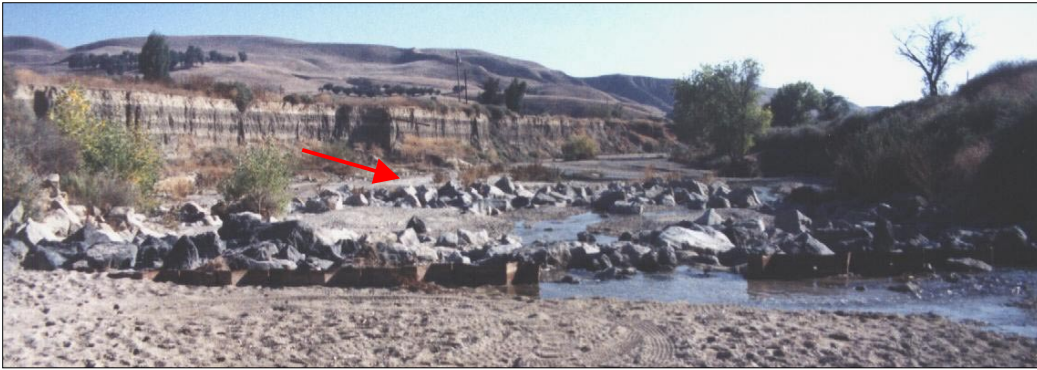
Photo 128. Looking downstream over sheet pile check dam. Piles of bridge 49-0095 were exposed, because creek bed degraded from downstream gravel mining and constricted channel. Check dams built in 1996 upstream and downstream of bridge, temporary scour countermeasures. Creek bed elevation raised 4 feet to about elevation 1024 feet. Prior 1-ton riprap around pier washed downstream (arrow).

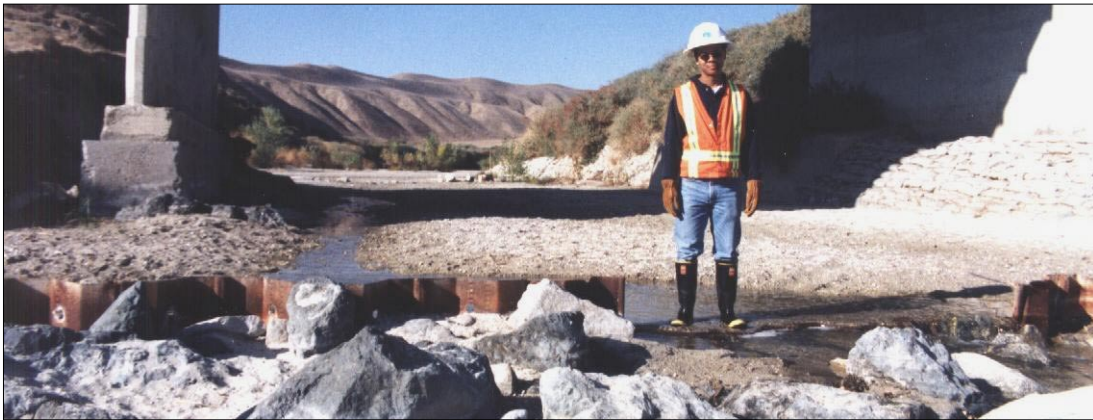
Photo 129. Looking upstream through weir notch in sheet piles. Weir notch controls low flow rates, limits opportunity for creek to erode ends of check dam. Sacked concrete bank protection was undermined, also repaired. 2-ton riprap dissipates flow over sheet piles, OK after high flows of January 1997. See photo 130.

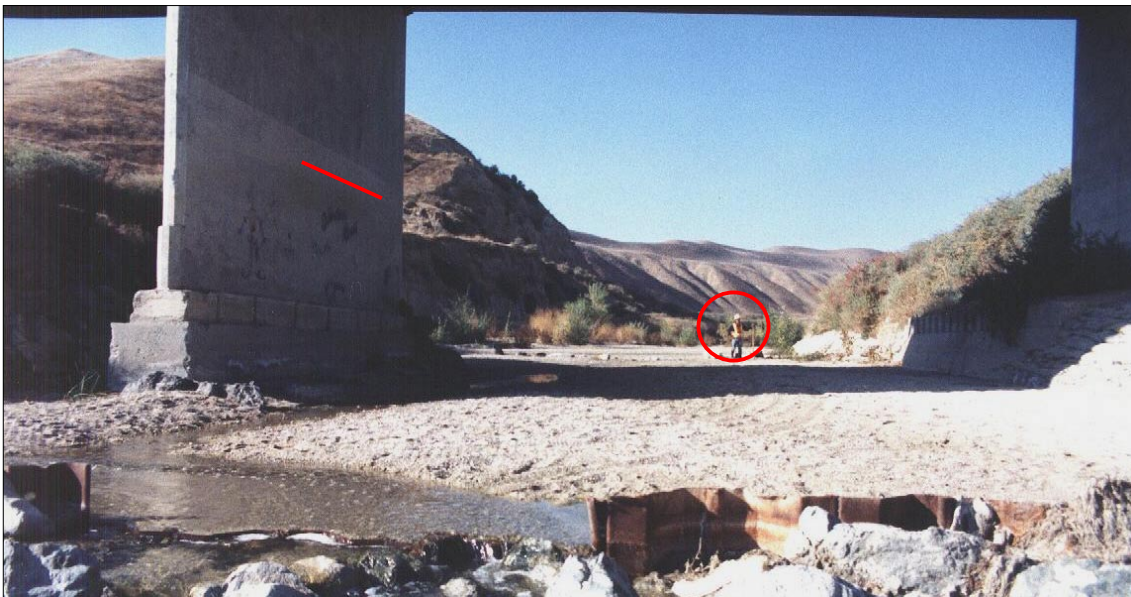
Photo 130. Looking upstream, to assure soil support around piles, a level-crested gabion check dam near researcher, (circle) was built from product 4. Riprap was placed up-and-downstream of the gabion structure. Both check dams OK after high flows of January 1997, high water mark (line) just below light paint on pier wall. Creek bed elevation was maintained at planned elevation of 1024 feet. RSP-fabric used for separation and filtration at both check dams and also around pier with 2-ton rock. Bridge will be replaced.

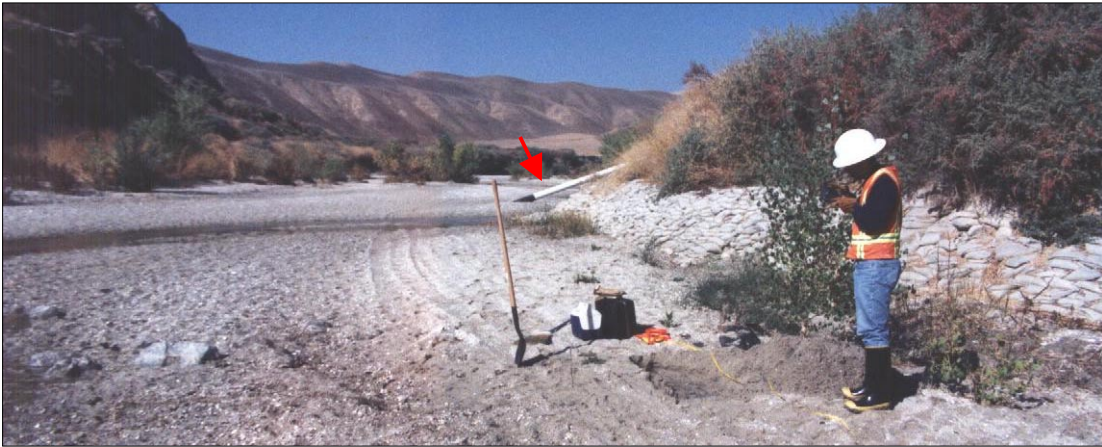
Photo 131. Found gabion check dam buried about 0.5 foot, looking upstream. Wire in very good condition after 2 wet seasons. Trickle flow meandered to opposite side of creek, soil was saturated. White-to-black natural gas pipe (arrow) exposed in degraded creek bed.

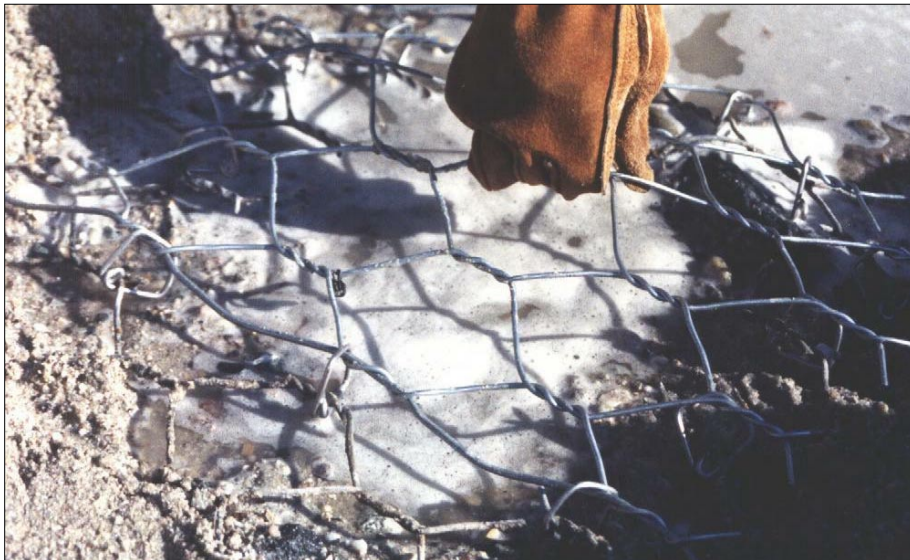
Photo 132. After collecting sample of check dam, lid panel was repaired with new section of product 4, 11-gage zinc-coated mesh and interlocking fasteners.

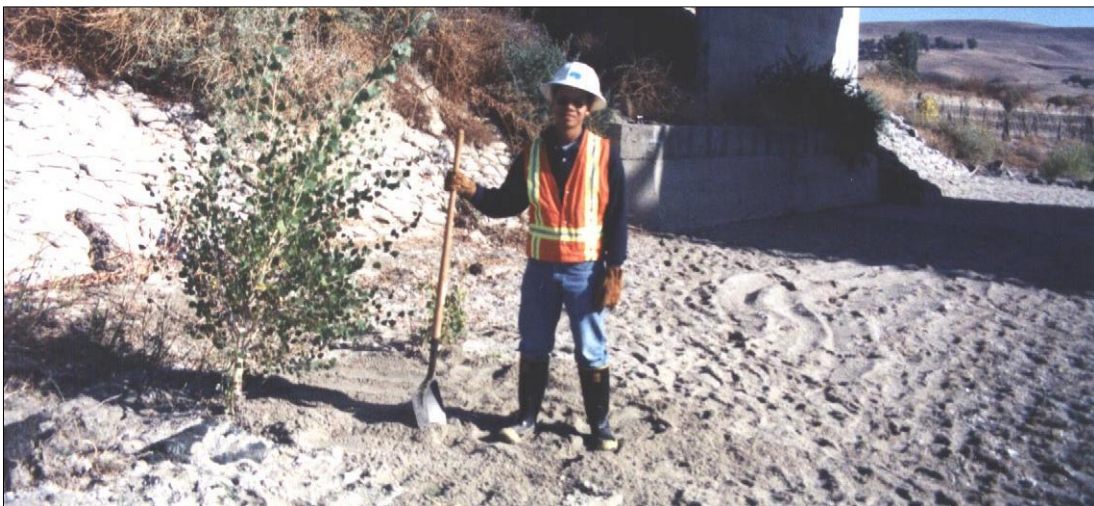
Photo 133. After repairing check dam, channel bed was restored to prior condition.

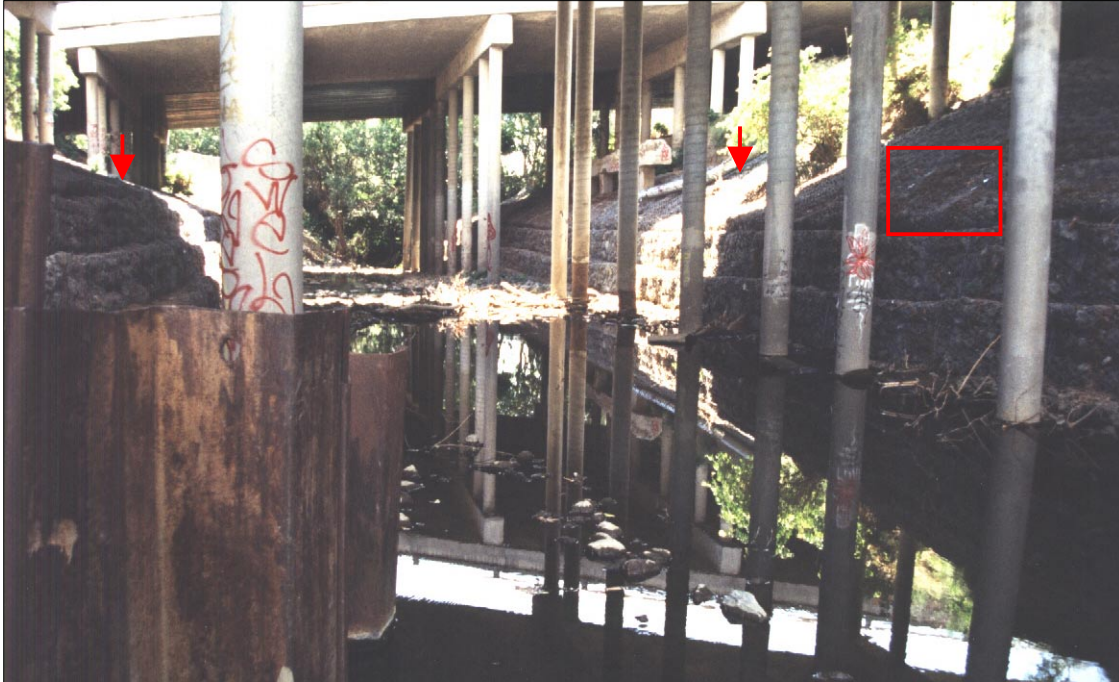
Photo 134. Looking downstream under bridges 23-0052 left and right, after one wet season.

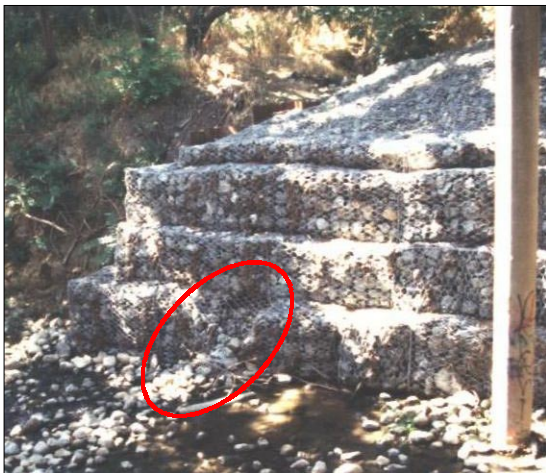
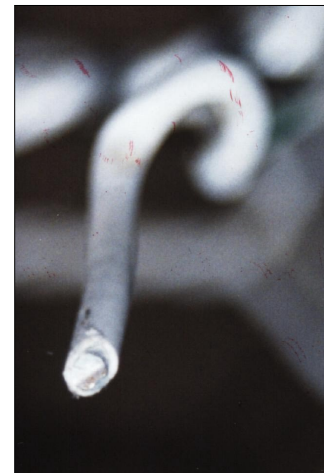
Photo 135 (left image). Another vandalized gabion in wall (oval). Flow is toward left and parallels wall. Downstream sheet pile check dam matches channel cross section, a few sections protrude above mattresses.

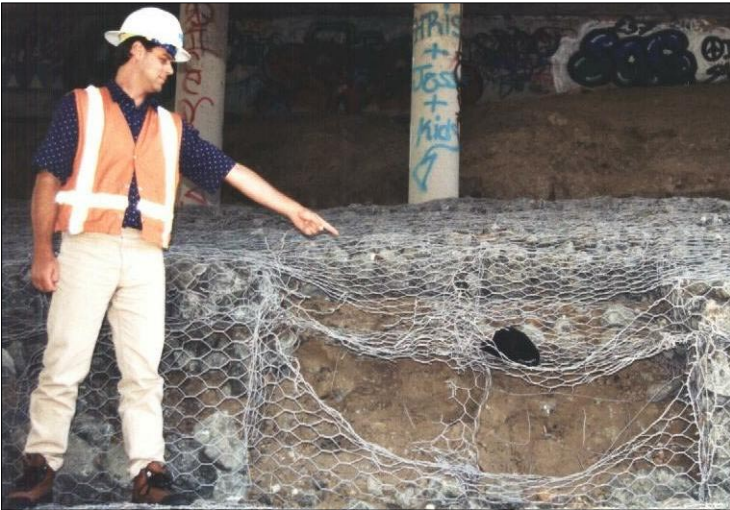
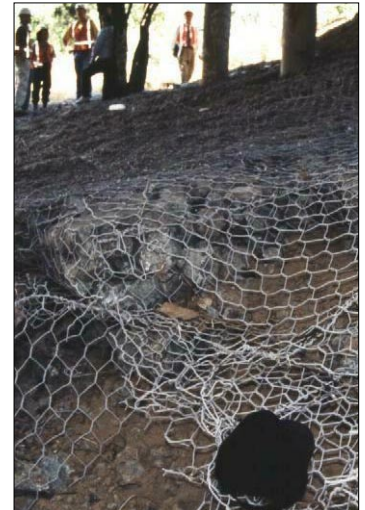
Photo 137 (left image). Vandalized empty gabions, top of wall, and no geotextile behind these empty gabion cells. PVC-coated mattress gabions extend just above Q100 stage, to protect upper slope (up to where gabions intersect pier 5 (behind observer). Black cap is for orientation in photo 138.

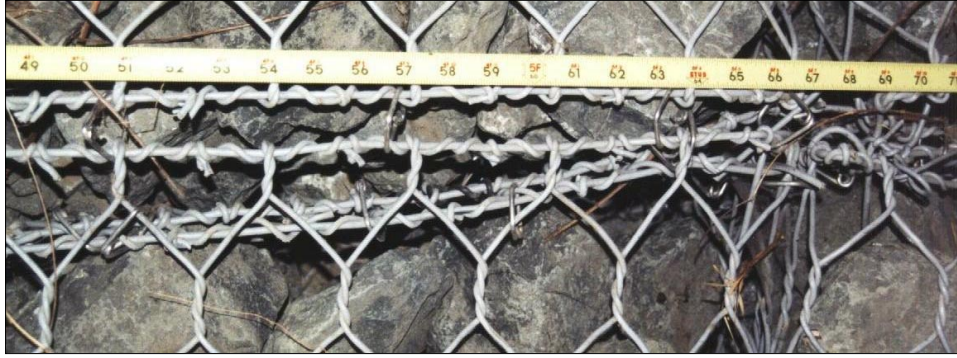
Photo 141. First of 3 out-of-specification joints using interlocking fasteners, lack of inspection and/or attention to Caltrans plans and specs. Supplier brochure showing fasteners at 6-inch intervals is not recommended by Caltrans. Caltrans requires one alternative fastener in each mesh opening along the joint, and if one fastener can not enclose all the wires in a single pass, then standard 13.5-gage tie wire must be used.

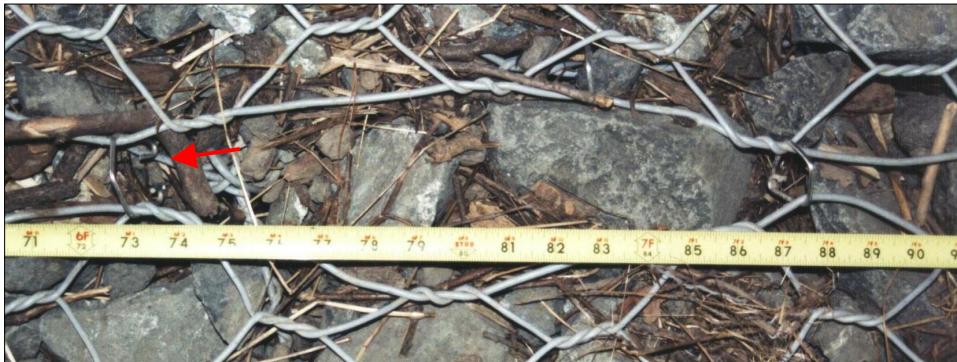
Photo 142. Second of 3 out-of specification joints, near 73-inch mark (arrow), fastener is not interlocked, then toward right, 2 fasteners are missing. Joint near high water, submerged by January 1997 flow, as indicated by drift (floating vegetative debris left behind after flood stage drops).

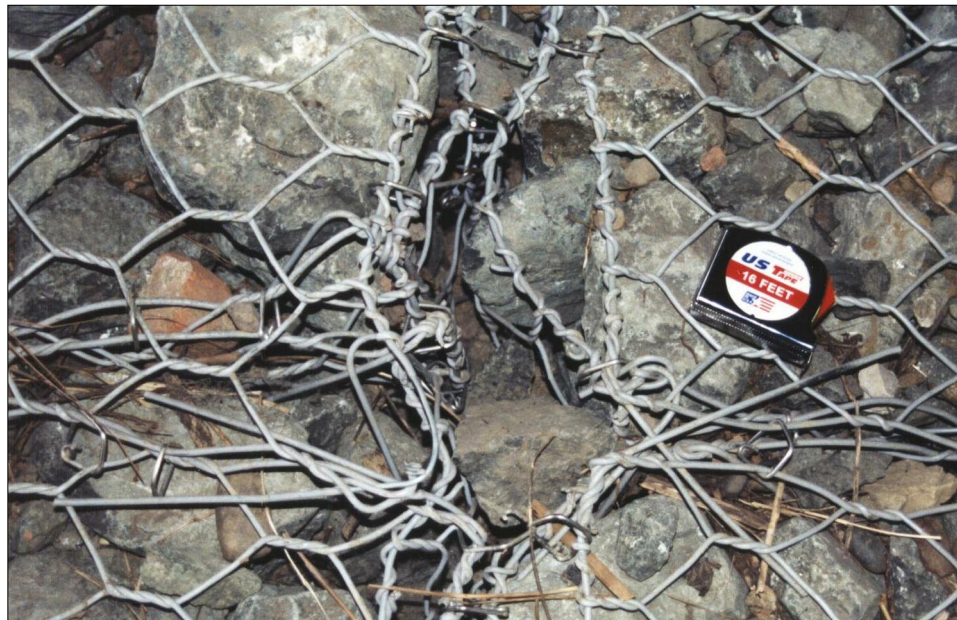
Photo 143. Third of 3 out-of-specification joints, four baskets not joined at corners, where multiple basket-to-basket joint is required. It appears empty baskets were laid out and filled with rock, then rocks were crammed into void where tied joint should be. Such practice is contrary to Caltrans and most supplier specifications, which require : form single baskets, join them, slightly over fill them with rock, close and fasten the lids.

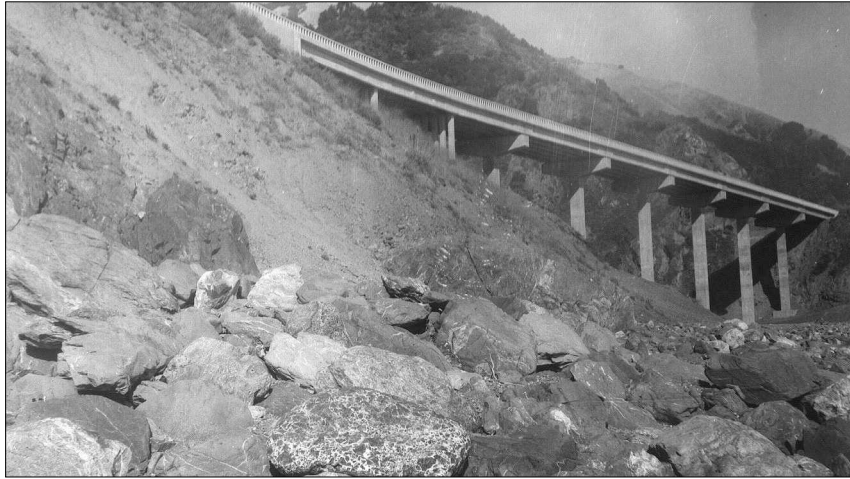
Photo 144. Distressed slope one year after construction with 4-ton RSP at toe of slope, 1958. Slope eroded (left center) and became over-steepened by storm wave attack. Looking southerly from beach at bridge number 44-0058, completed 1957. Northerly abutment 10 at upper left, piers 9, 8, 7, etc. are southerly toward right, pier 3 in Lime Kiln Creek. Elevation difference of beach to roadway is about 100 feet.

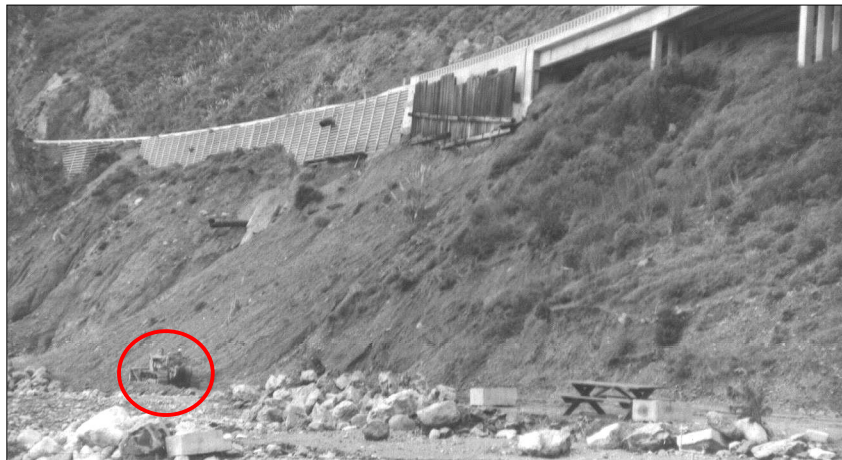
Photo 146. On 7 Jan 1974 slope failed below abutment 10 and approach road crib walls. Looking northerly from beach. On 9 Jan 1974 dozer (circle) started grading for near sea-level crib wall to stabilize toe. Continual toe erosion, twice daily high tide to elevation 6 feet, storm waves seen higher than elevation 25 feet.

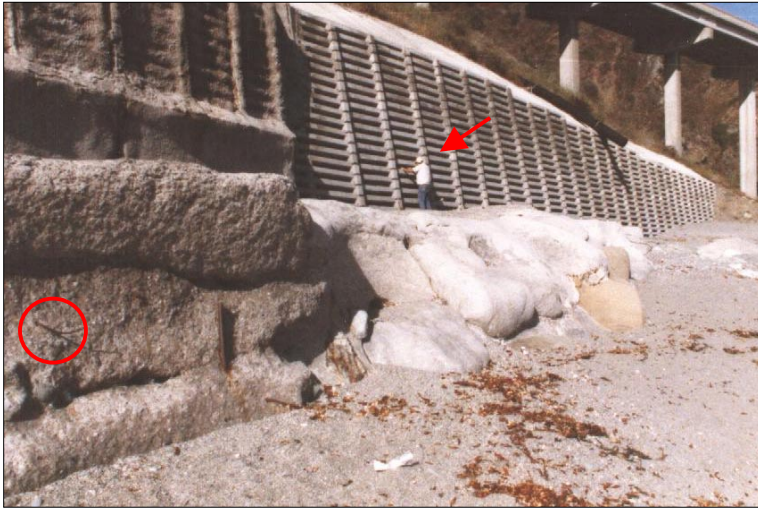
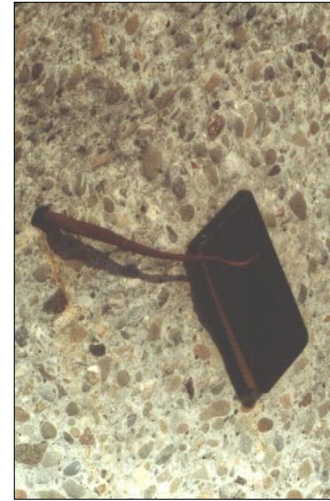
Photo 147 (left image). Researcher (arrow) inspects failing new 150-foot long concrete crib wall, built 1988. Front closure members fell into cribs. Wall top elevation is 30 to 34 feet. Looking southerly from beach after 2 wet seasons, 25 Jul 1990. Gabions (product 5) built in front of new wall, covered with a foot of sand for recreational beach use. Mattresses cabled to wall, extended 12 feet from new wall. Concrete butress (left foreground) built about 1976 is 150' long x 20' wide from elevation 3 to 9 feet, protects toe of old concrete crib wall from wave attack (built 1974), later faced with air blown mortar. Kelp is limit of recent high tide waves.

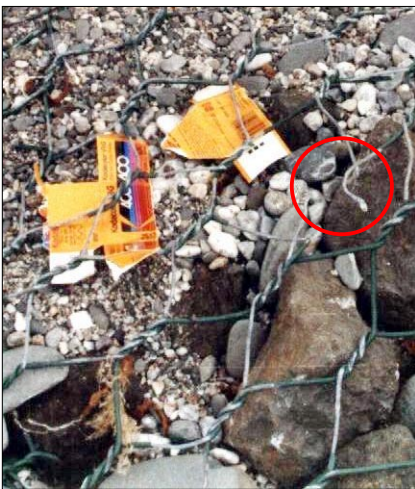
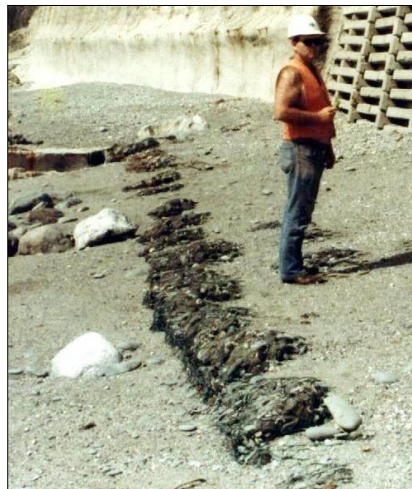
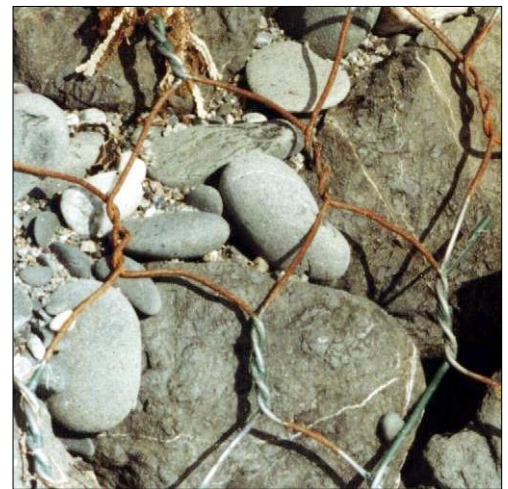
Photo 149 (left image). Gabions partially exposed after 2 wet seasons, some PVC missing, 26 Jul 1990. Wire broke (circle) possibly by rock impacts. Note particle sizes.

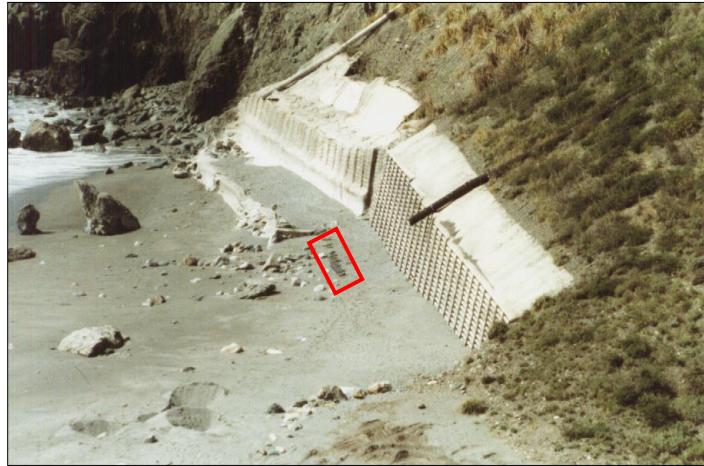
Photo 152. Partially exposed gabions (box), 10 Mar 1992, looking northerly. See photos 150 and 151.
