# GABION MESH CORROSION

## Field Study of Test Panels and Full-scale Facilities

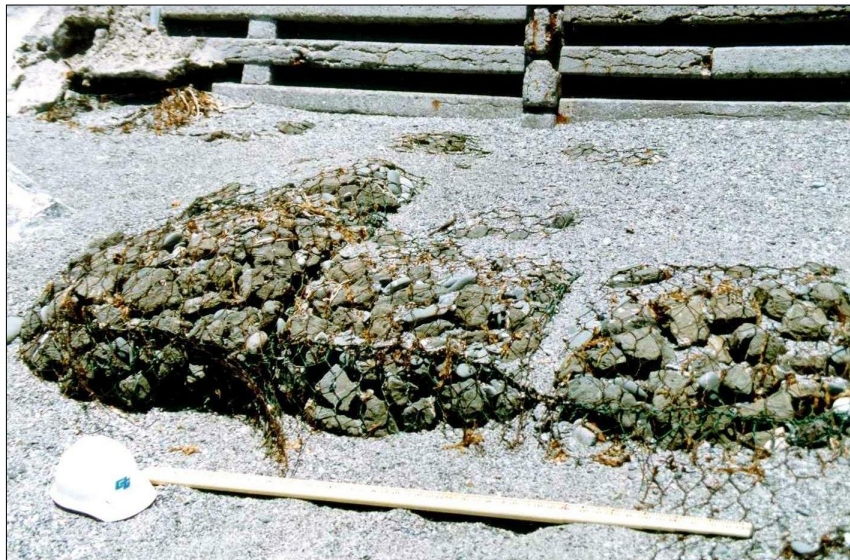
Photo 153. After 5 wet seasons, near join to old crib wall, gabions on left OK, while gabion at right failed, part of lid was opened, right foreground, 1994.

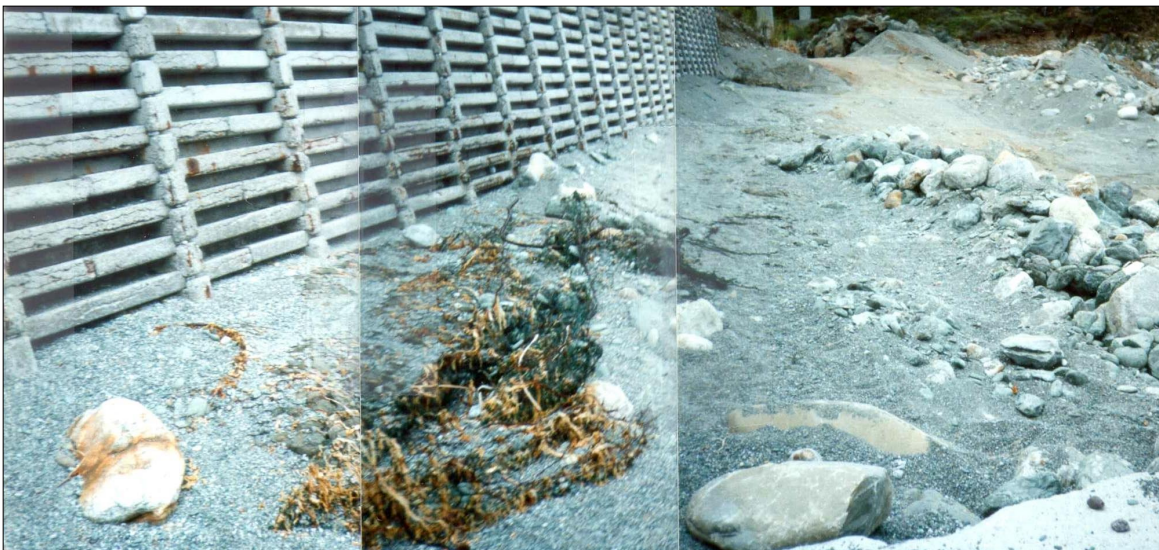
Photo 154. During 6<sup>th</sup> wet season, waves and rocks hammered new crib wall, some gabion cells were emptied by wave action, boulders were strewn about, looking southerly 15 Aug 1995. By this time, new crib wall was so distressed, it needed to be replaced or buttressed.

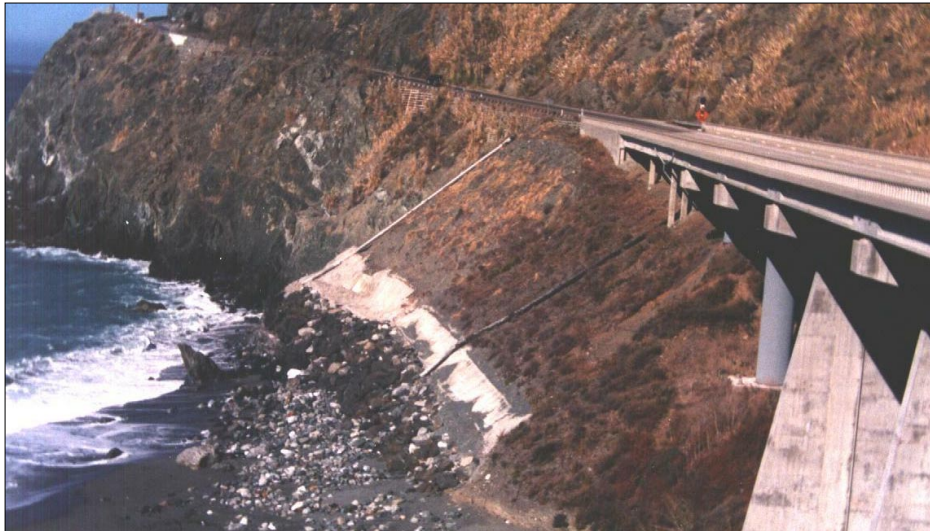
Photo 155. Walls buttressed by 8-ton rock, built 1995, looking northerly, 5 Nov 1998. Nonwoven, heavy-duty (16 oz / sqyd), high permittivity ( $>0.5$  per second) RSP-fabric initially placed on beach and against walls.

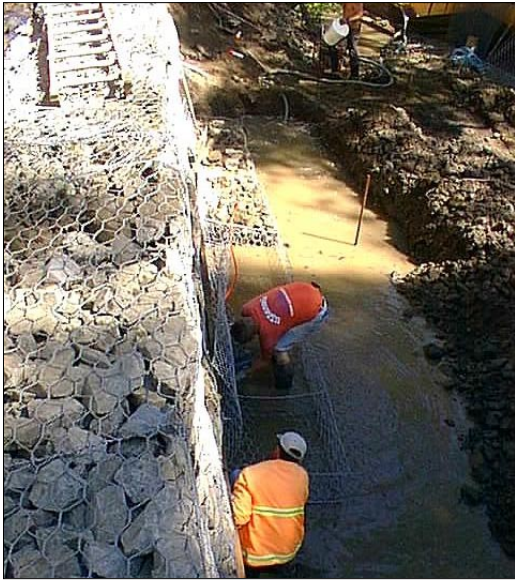
Note. There are two interesting features and material designs nearby : one is upstream and the other is downstream of the gabion wall. Their detailed documentation is beyond the scope of our wire corrosion report, however, they are seen in the photos. As a restoration effort for mitigating the effects of the gabion wall, immediately upstream there are root wads for enhancing in-stream habitat. Immediately downstream of the gabion wall, there are 75-pound interlocking concrete armor units that are embedded in the creek bed at the toe of slope. They are intended as bank toe protection.

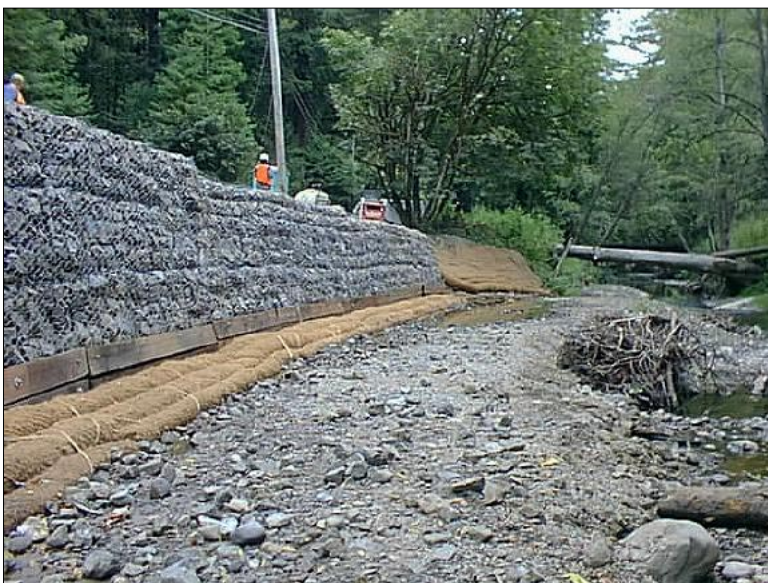
Temporary abrasion boards are a trial feature prompted by lesson learned at site 2. They are intended to protect gabions from abrasion. 2"x12" boards were mounted on 5/8-inch (16 mm) diameter galvanized rods that went through gabions. Washers and hex-nuts hold boards on wall and allow replacing any dry-rotted or excessively worn-out boards.

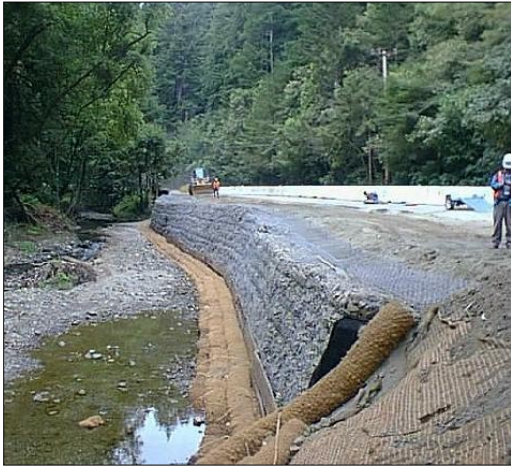
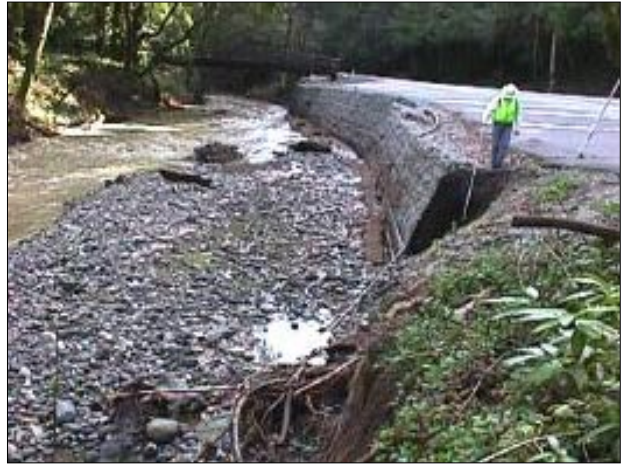
Photo 161 (left image). Gabion wall, gabion toe scour mats and coir fiber rolls completed, 28 Jul 1999. Looking upstream. Coir turf reinforcing mat staked to slope. Fiber rolls tied to mats with 1/2-inch coir rope.

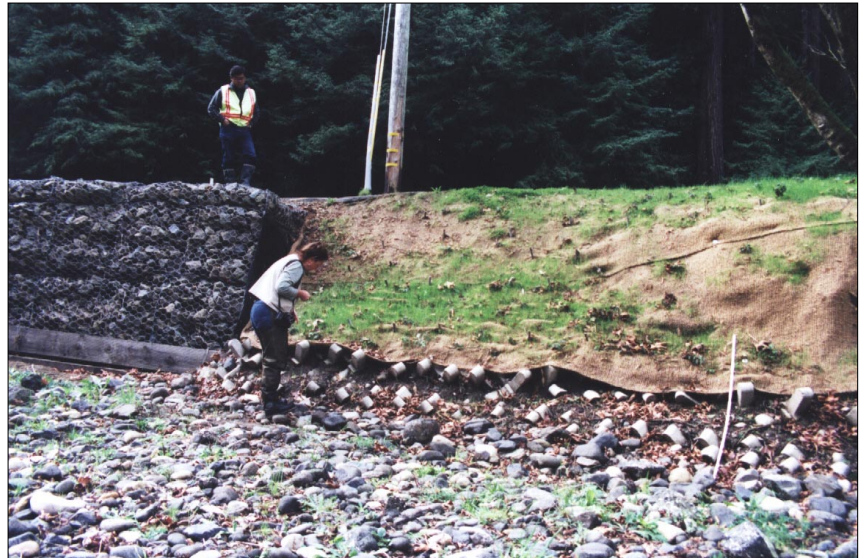
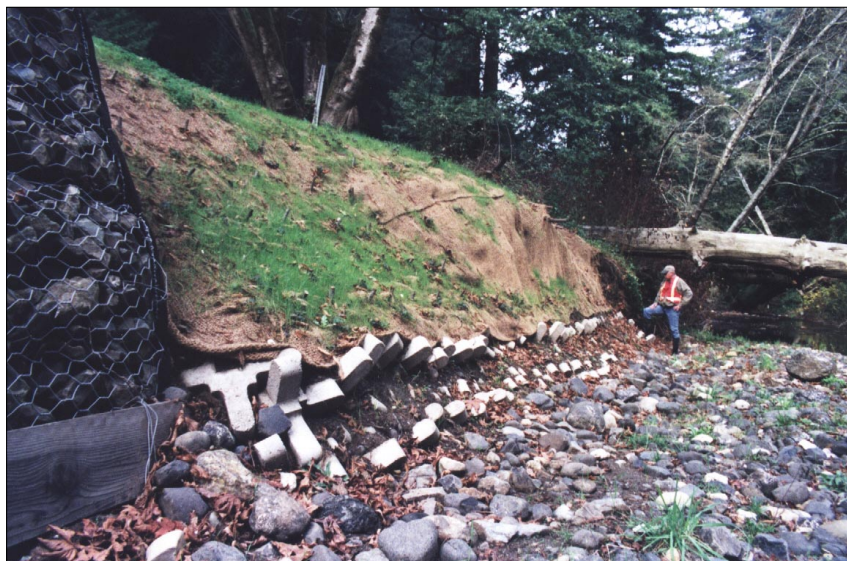
Photo 164.  
Abrupt change from gabion wall transitions to stream bank with 75-pound interlocking concrete armor units (AJACKS) to prevent toe erosion beyond wall.

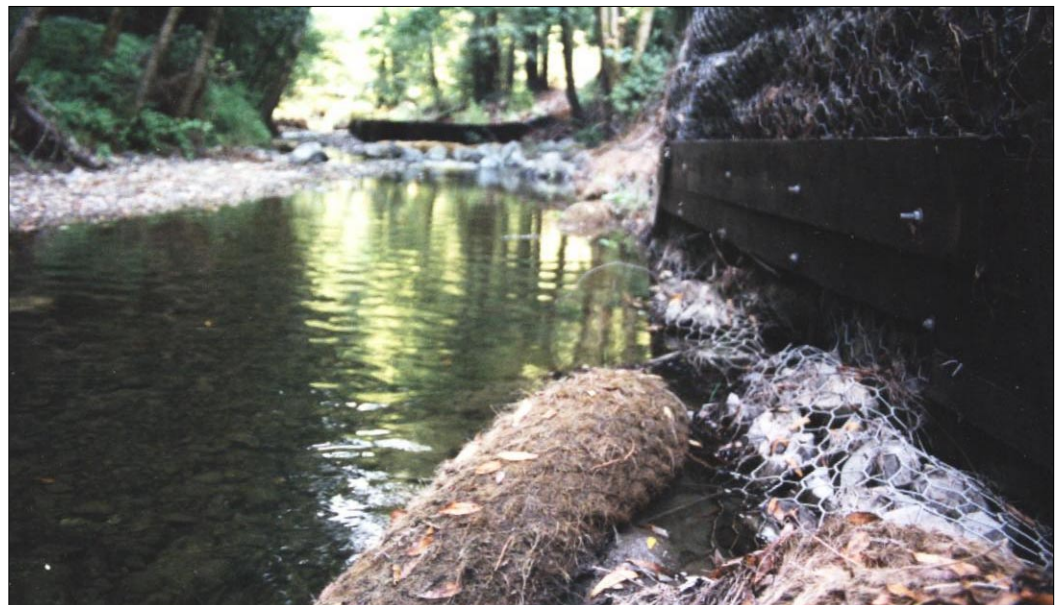
Trees (upper left) leaning toward creek, bed material locally scoured under roots.

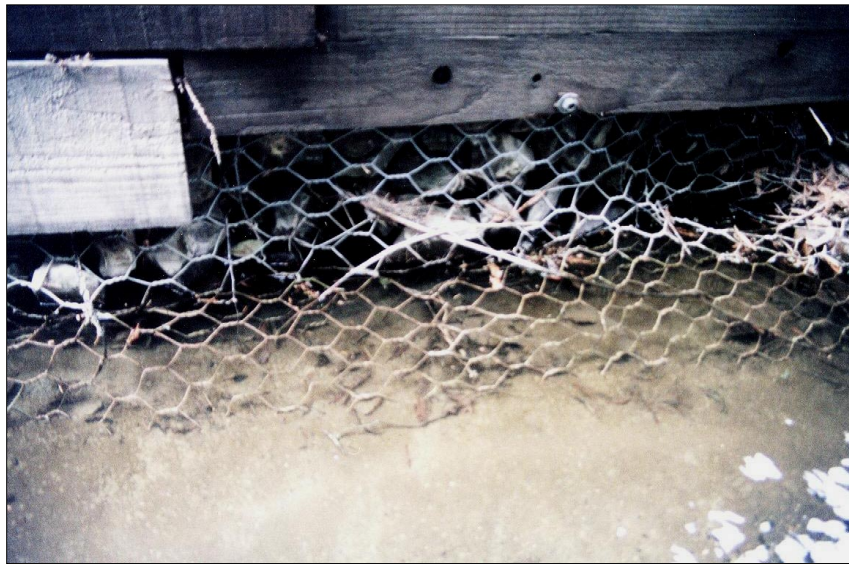
Photo 175. Bottom half of abrasion board missing. Bottom boards installed about 1-foot too high.

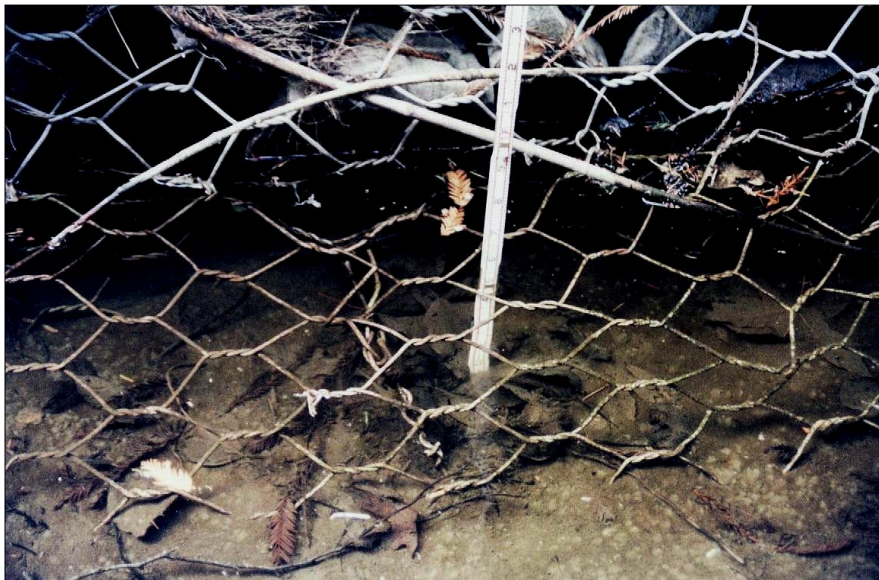
Photo 176. About 0.5-foot (indicated by 1<sup>st</sup> joint of folding ruler) of gabion rock-fill either settled, or it was too small and was scoured through mesh during storm runoff. Brown tint is silt on submerged PVC, not rust.
