## CONTROL OF STREAMBANK EROSION DUE TO BED DEGRADATION WITH VEGETATION AND STRUCTURE<sup>1</sup>

*F. D. Shields, Jr., A. J. Bowie, and C. M. Cooper<sup>2</sup>*

**ABSTRACT:** Combinations of vegetation and structure were applied to control streambank erosion along incised stream channels in northwest Mississippi. Eleven sites along seven channels with contributing drainage areas ranging from 12-300 km<sup>2</sup> were used for testing. Tested configurations included eroding banks protected by vegetation alone, vegetation with structural toe protection, vegetation planted on re-graded banks, and vegetation planted on regraded banks with toe protection. Monitoring continued for up to 10 years, and casual observation for up to 18 years. Sixteen woody and 13 nonwoody species were tested. Native woody species, particularly willow, appear to be best adapted to streambank environments. *Sericea lespedeza* and Alamo switchgrass were the best nonwoody species tested. Vegetation succeeded in reaches where the bed was not degrading, competition from kudzu was absent, and bank slopes were stabilized by grading or toe protection. Natural vegetation invaded planted and unplanted stable banks

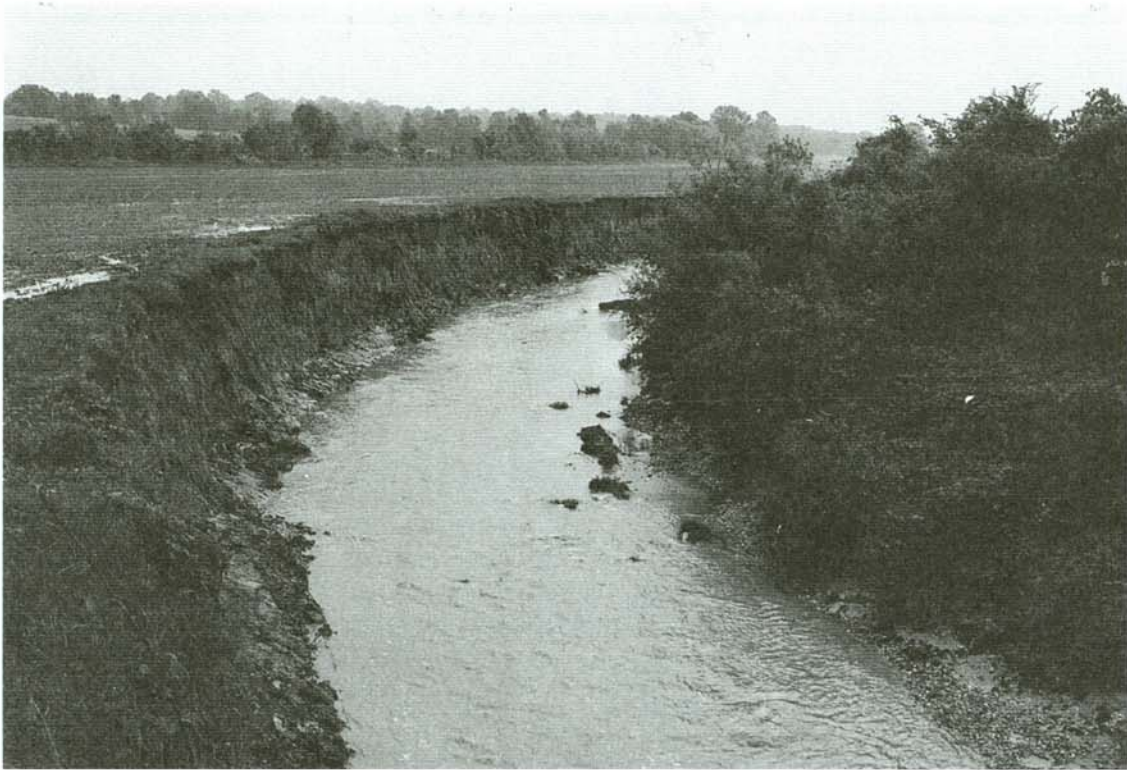
Figure 1. Erosion Triggered by Channel Erosion. Channel shown drains only 16 km<sup>2</sup>, but bank height is between 4 and 5 m. Photograph is looking upstream from downstream end of site VTS2.

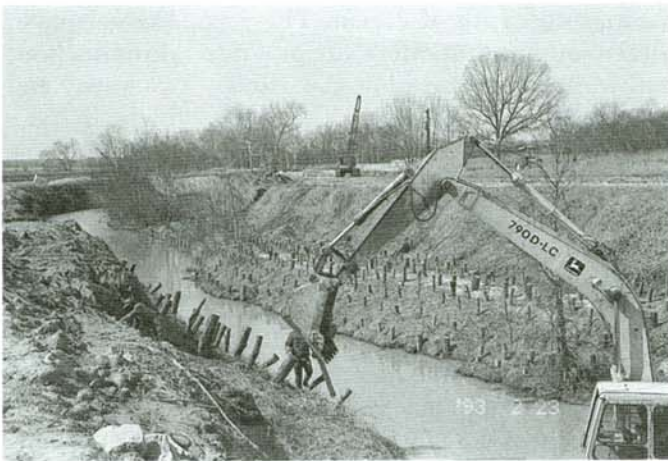
Figure 3. Planting Dormant Willow Posts With Hydraulic Hoe and Ram at Site V3.

planted 1.2 m deep in the face and along the toe of steep, slowly eroding banks by making holes using a metal ram mounted on an hydraulic hoe (Figure 3). Dormant posts were also used at V4 and V5, but they were planted in sandbars in an effort to restore riparian zones and canopy destroyed by incision-induced channel widening (Volny, 1984). Posts were planted in a series of 1.2-m-deep pits excavated in the sandbar just parallel to the base flow channel. Square pits (about 1.2 m x 1.2 m) were dug within 5 m of the water's edge with an hydraulic hoe, and 10 to 12 posts were placed vertically around the perimeter of each pit before refilling.

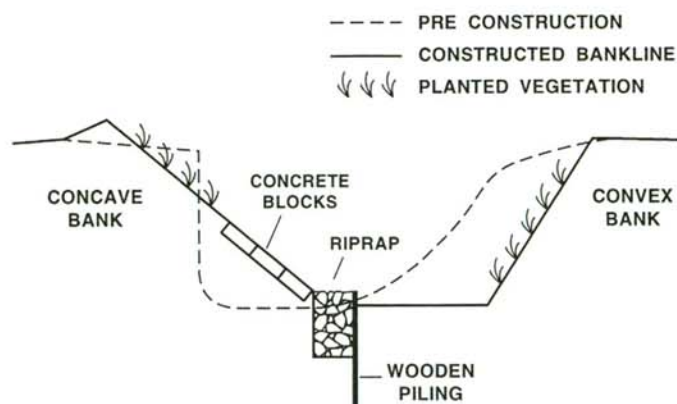
Figure 5. Typical Cross Section (simplified) of Design Involving Vegetation, Bank Shaping, and Structure.

Three reaches along two channels were stabilized by grading banks to more gradual slopes, planting vegetation, and placing structure at the toe of concave banks (Figure 5). Shaped banks were graded so that the top of the finished bank sloped away from the channel to prevent drainage of runoff over the face of the slope. Full details of protection designs are provided by Bowie (1982). Two of the reaches (VTS2 and

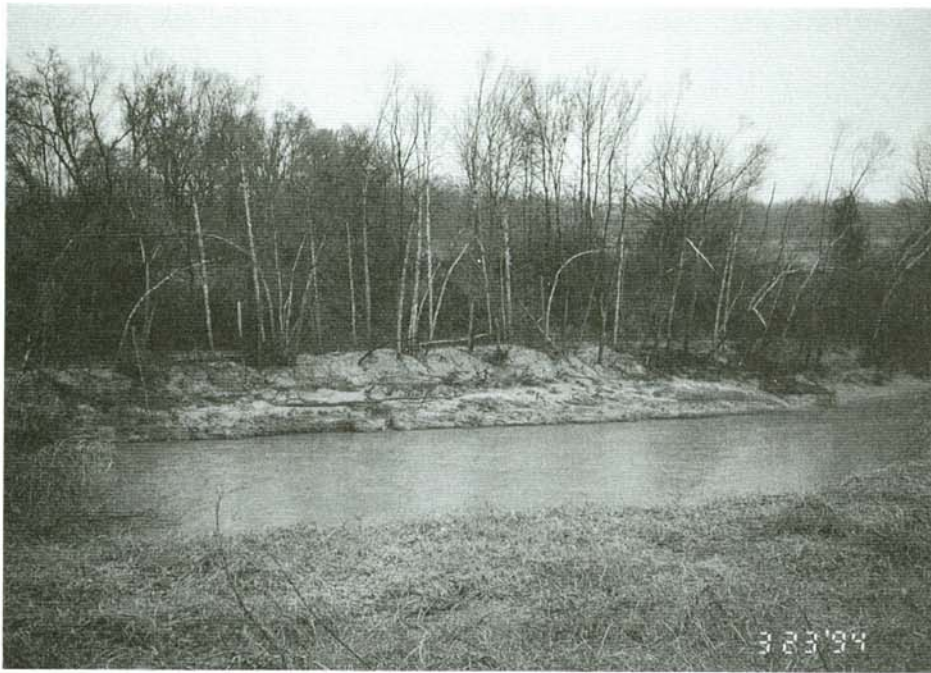
Long-term results, which were available for V1 and V2, illustrate the importance of bed stability. Two of the five species planted at V1 had short-term survival rates  $> 50$  percent, and the planted banks were stable over the short term. However, when V1 was inspected 17 years after planting, headcuts that Schumm *et al.* (1981) found downstream of V1 had evidently moved through the reach, causing considerable bed erosion and bank failure. In contrast, the initial planting failed at V2, and short term survival rates for the second planting were relatively low (Table 2). However, banks were generally stable over the long term. By 10 years after planting, native species had taken over all stable banklines. Five of the six unplanted plots were stable and supported dense woody vegetation, equaling or exceeding the performance of the treatments involving planting. Figure 6 depicts typical conditions in the V2 reach 20 years after initial planting and 18 years after replanting. Bank stability was likely related to the fact that the V2 bed was stable to slightly aggradational during the period of observation (Schumm *et al.*, 1981; Watson and Alexander, 1989; Fullerton and Grindeland, 1990).

Figure 6. Site V2 About 18 Years After Vegetation Was Replanted. Stands of river birch and black willow 30-cm in diameter by 10-15-m high alternate with areas covered by kudzu. Note sand deposition at toe of opposite bank.

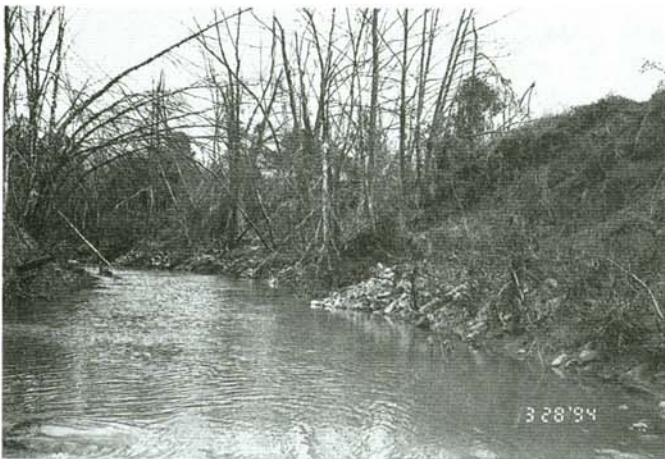
All three of the reaches protected by vegetation and structure at the bank toe remained stable in spite of rigorous environmental conditions (Figure 7). The survival rates shown in Table 3 for VT1 and VT2 were measured following a growing season (1980) for which precipitation was only 33 percent of normal (Bowie, 1982) and temperatures were an average of 1.8°C above normal (National Climatic Center, undated). Channel surveys showed 30-60-cm of bed degradation

Figure 7. Typical View Within Site VT2 16 Years After Construction. Schematic of design is shown in Figure 4.

riparian trees (willow and river birch), while the third, which was adjacent to a bridge, had been replaced by a riprap revetment. At VT2, natural vegetation took over both the planted and the unplanted areas landward of the stone toe within three years. Evidently, banks landward of the stone toe caved to their angle of repose, and transport of caved material was prevented by the toe protection. In a short period of time, the caved material was vegetated, and active erosion was eliminated.

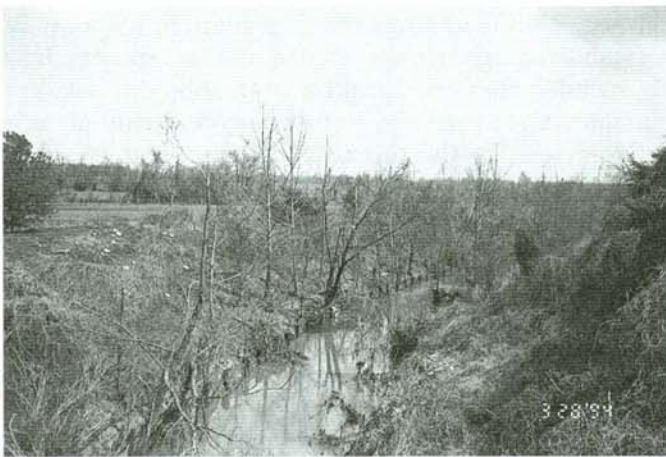
Study reaches with shaped banks were subjected to severe climatic stresses during the 12-year period of observation, but they remained well-vegetated and stable (Figure 8). Planted and native species gradually invaded areas protected by rock and concrete blocks, colonizing deposited sediments and interstitial soils (Figures 7 and 8), and perhaps increasing the strength of the block revetments (Hewlett *et al.*, 1987). Rainfall for four of the growing seasons was extremely light, ranging from no rainfall for 30 consecutive days to an average of only 43 percent of normal. During these dry periods, temperatures were  $4\text{--}7^\circ\text{C}$  above normal levels for several successive days. Record low temperatures occurred in three consecutive winters, falling  $3^\circ\text{C}$  below normal for 28 successive days during 1985.

Figure 8. Site VTS2 13 Years After Construction. This photograph is taken from the same point as Figure 1. Schematic of design is shown in Figure 5.

flows occurred in the second and third years. About 1 m of bed degradation occurred at VTS1 during the first two years following construction. This bed lowering caused rock and cellular block revetment to slide down the bank, exposing the underlayer of geotextile. Nevertheless, banks in all three of the reaches subjected to shaping remained stable. Degradation was halted by completion of a grade control structure immediately downstream from VTS1.
