# Watershed Restoration Technical Bulletin

Vol. 6 No. 2

## Five Years of Restoration at Sinmax Creek

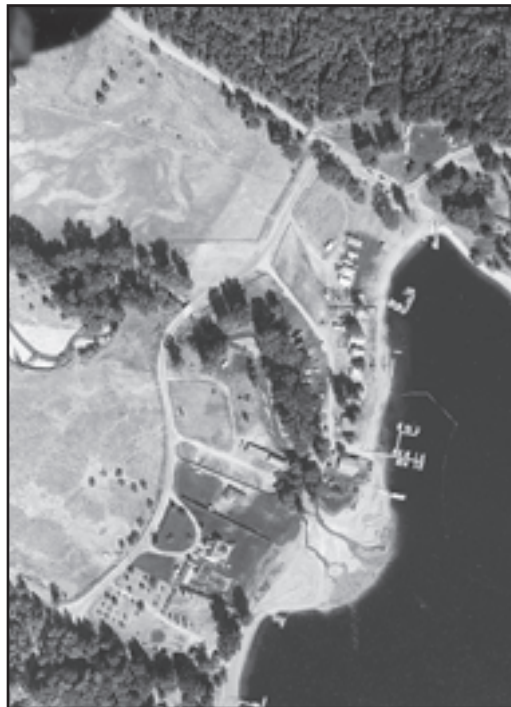
Figure 1. September 1998. Sediment fan formed by Sinmax Creek in Adams Lake.

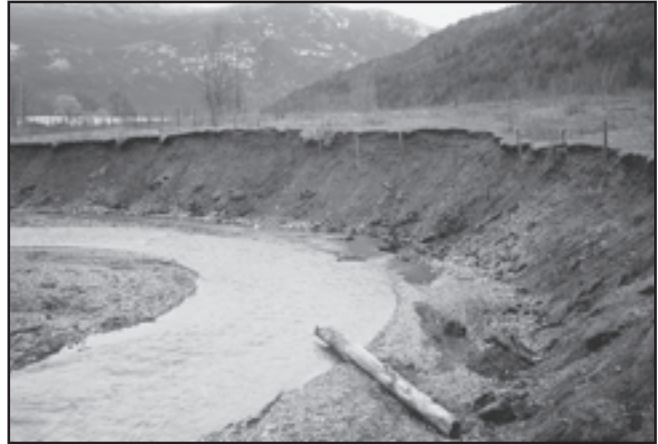
Figure 3. March 1999. Eroding right bank at Site B prior to construction.

- An 80m long rock and rootwad revetment was constructed along the base of a 4m high cutbank (Figures 3, 4 and 5)

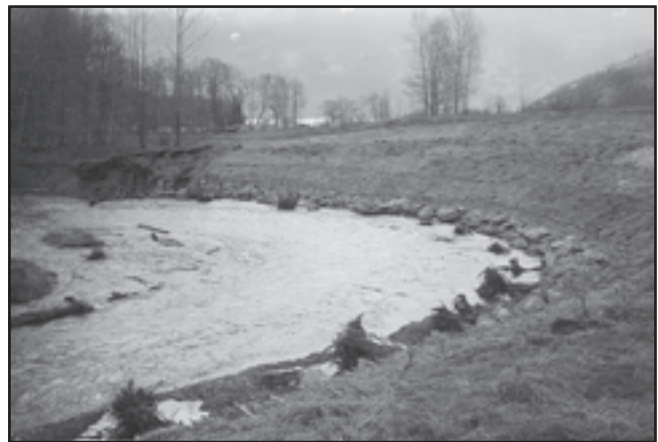
Figure 4. April 1999. Site B during freshet immediately following construction. Note low velocity areas created by rootwads.

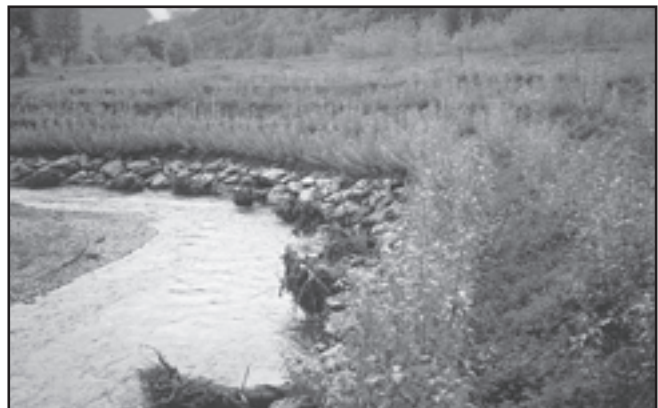
Figure 5. July 2000. Site B after two seasons' growth. Note elevated rootwads.

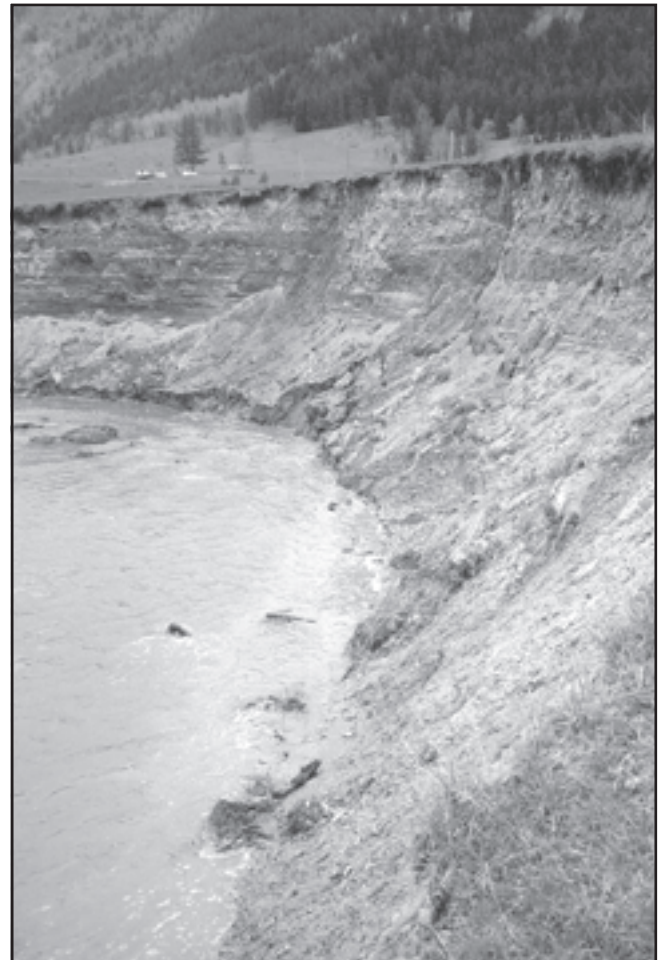
Figure 6. April 1999. Highly erodible left bank (4m high) at Site F during freshet. Note discoloured water along toe and active sloughing.

- A 90m low profile rock revetment with large woody debris was constructed on the left bank to protect a 5m high cutbank (Figure 6) and maintain a natural 'S' bend in the creek

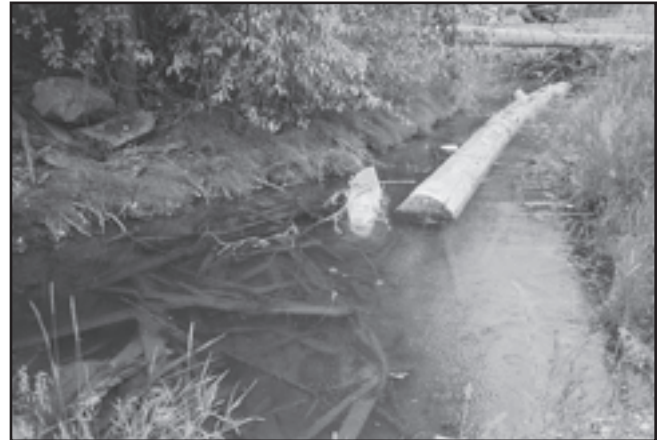
Figure 7. July 2001. Off-channel pond constructed at Site E.

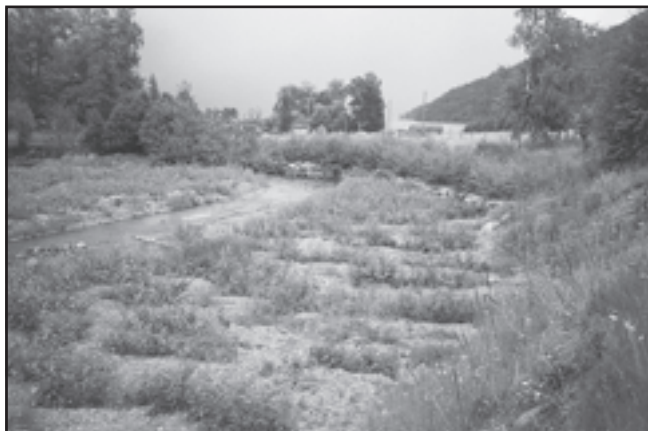
Figure 8. July 2001. Site A showing brush transverse planted the preceding fall.

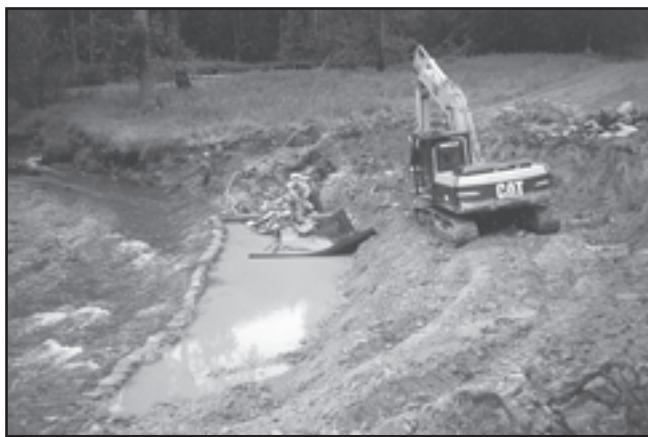
Figure 9. July 1999. Using sandbags and trash pump to control sediment during construction of revetment at Site F.

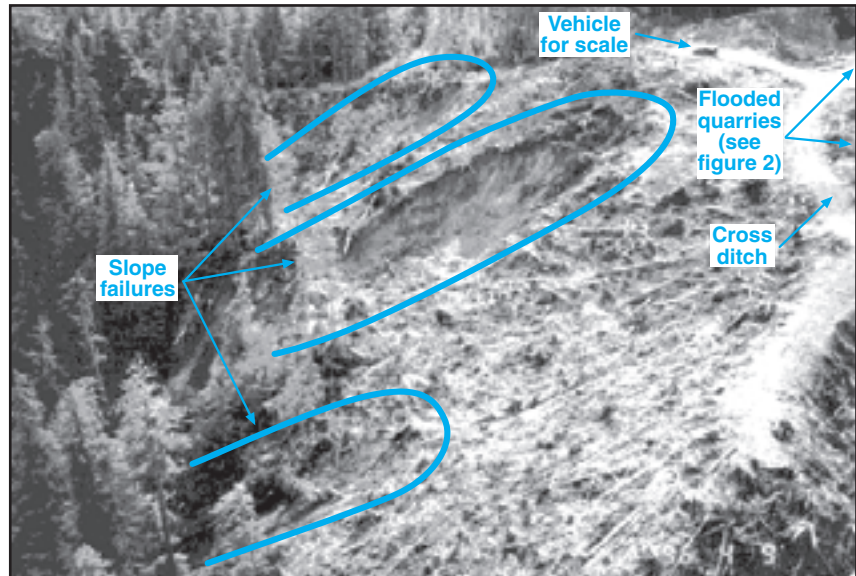
Inexpensive management of surface water could have prevented the slope failures illustrated in Figure 1. The slides occurred upon a creek escarpment on the east coast of Graham Island, Queen Charlotte Forest District. Since it was harvested in the early 1990's this escarpment has produced an estimated 50 landslides, from 20 slide zones. Slope stability investigations have revealed that the escarpment is composed of medium plastic till. The till is among the most plastic (clay-like) of the soils a forestry worker can reasonably expect to encounter along coastal British Columbia. Inexpensive management of surface water would have prevented the worst of the slope failures upon the escarpment. Had the rock quarries in Figure 2 been built to be free draining, the slides in Figure 1 should not have occurred.

Figure 1. Large slope failures in a plastic or clay-like till. Notice the flooded quarries and cross ditch above the slide headwalls that chronically moistened and softened the clay-like soil.

- ensure ditches and rock quarries are free draining,
- conduct wet season road inspections to detect, and remedy in a timely manner any seasonal areas of water ponding or concentrated natural slope drainage,
- be generous with cross drains, culverts, and cross ditches when building or deactivating road in similar terrain,

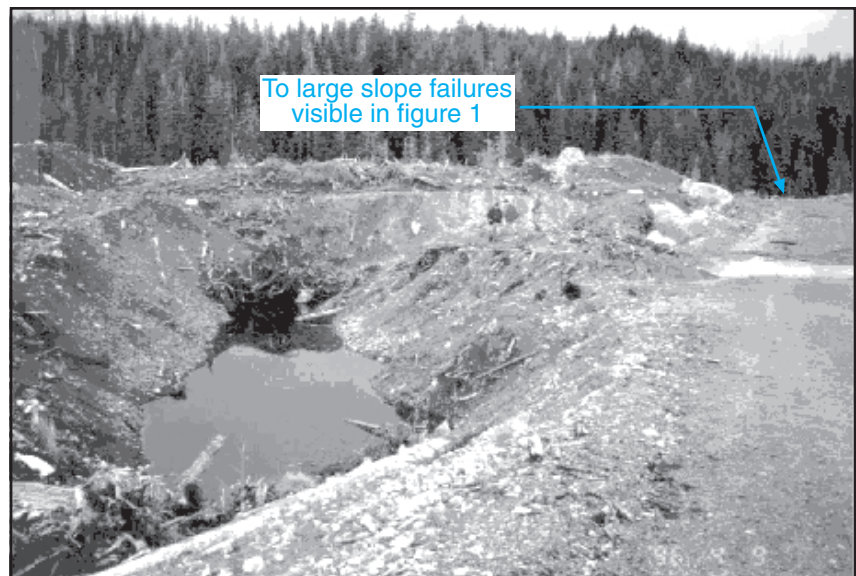
Figure 2. Flooded quarry above headwall of largest slide visible in figure 1. Immediately to the right of this photograph there was a second flooded quarry (see figure 1).

Abandoned, flooded, rock quarries (Figure 2) are a good method of injecting water into a clay-like hillslope. Naturally occurring tension, and sidecast road fill 'settlement', cracks have similar effects. Cross drains (culverts or cross ditches), which constantly moisten specific points upon a hillslope, can produce a similar, albeit, more localized softening effect. The water filled quarries associated with the slides in Figure 1 were probably flooded and softening the adjacent hillslope for about seven years before the largest of the slides occurred. This is in general accordance with the rules of thumb for water table fluctuations to soften, or harden, clay-like hillslopes (Chatwin et al., 1994).

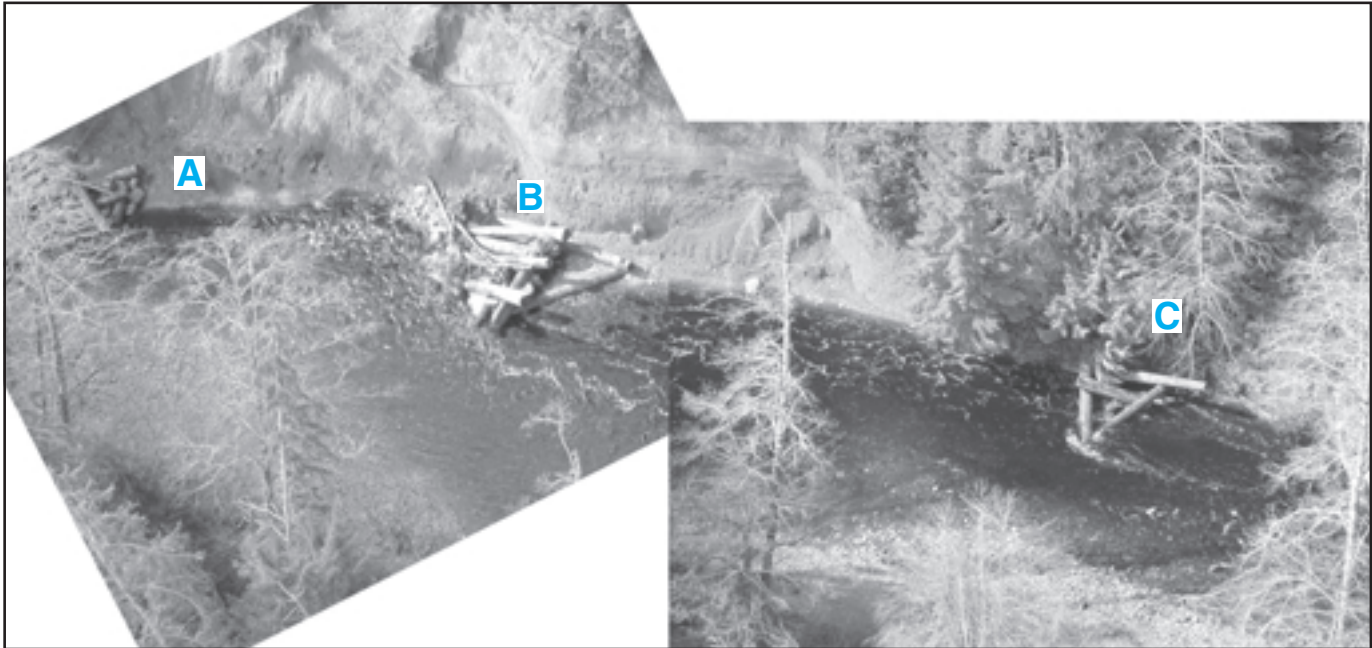
- Spacing details are in Figure 8
- Spur B is deflecting flow away from bank
  - note flow streamlines off tip
  - note dead water area on downstream (right hand) side of spur
