ISU – FHWA – ACPA Surface Characteristics

Relating Pavement Texture to
Tire-Pavement Noise using RoboTex

July 2006

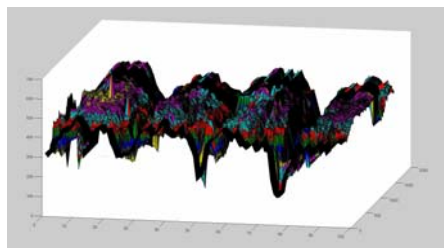
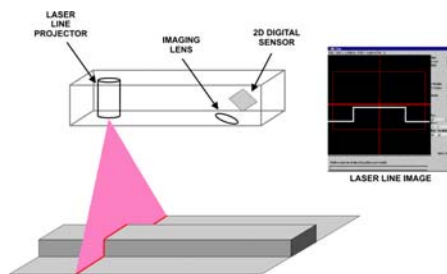
RoboTex

- Robotic Texture (RoboTex) built around LMI-Selcom RoLine line laser
- 3-D texture profiling at 0.9 mm × 0.45 mm sample interval
- Height sensor resolution is 0.01 mm (accuracy ~ 0.05 mm)
- Same line laser unit currently being evaluated by profiler vendors to help solve “footprint” issues

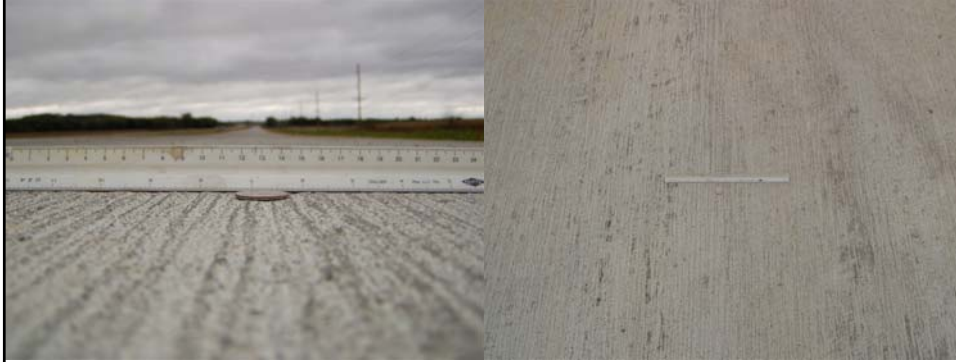
Burlap Drag

100.7 dBA 3

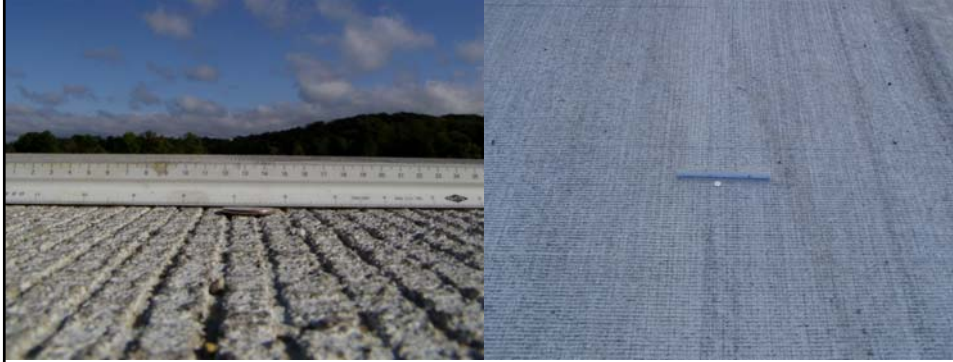
1/16" Deep Transverse 1/2" Spacing + Burlap

101.4 dBA

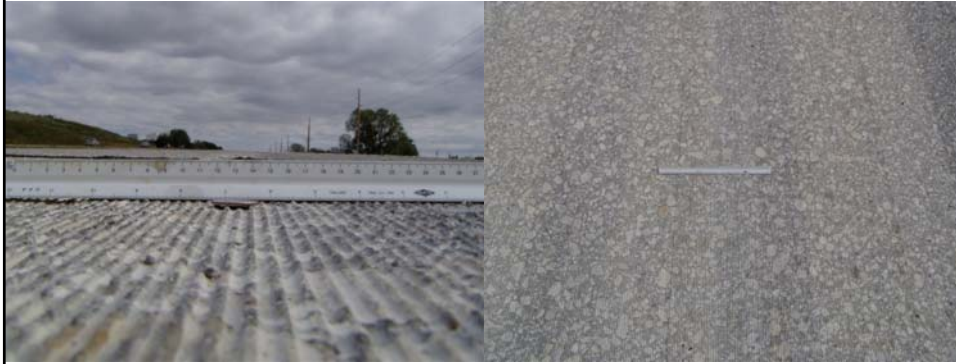
Diamond Grinding

102.9 dBA **11**

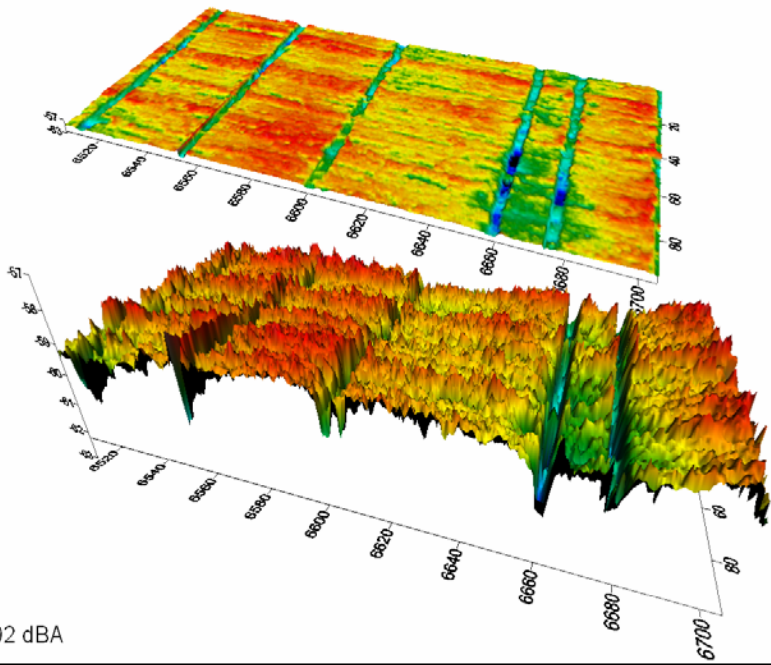
1/8" Deep Transverse Random Spacing + Burlap

108.4 dBA **17**

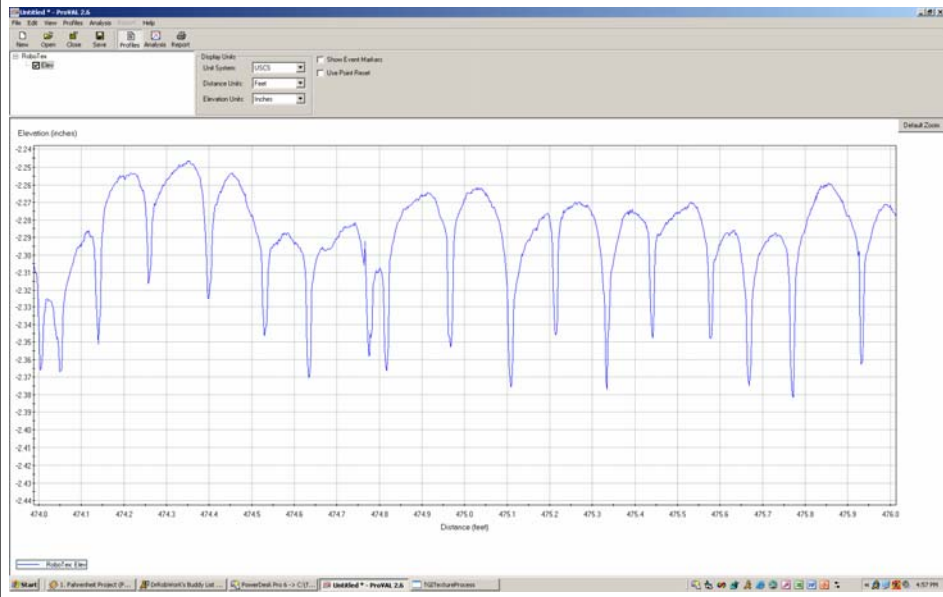
1/8" Deep Transverse Random Spacing + Burlap

108.4 dBA **17**
