## Restoration in the Pit River Watershed

## **ABSTRACT**

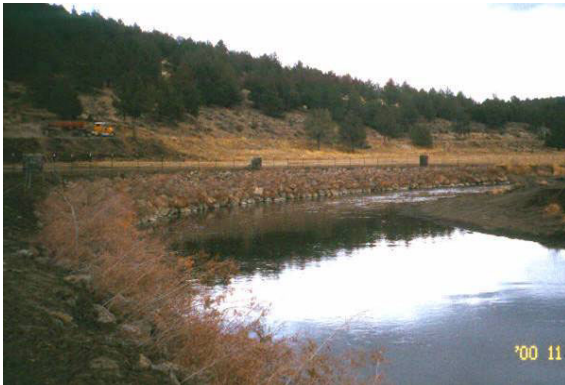
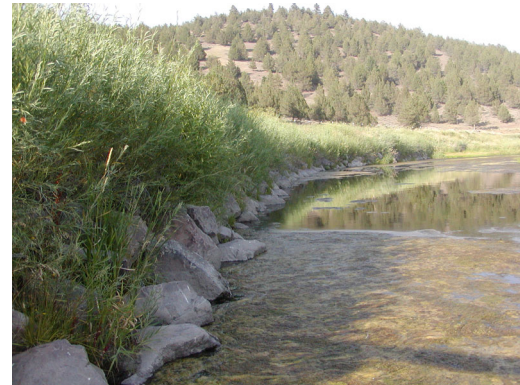
***Bushey Project: Vegetated Riprap 1 month and 1.5 years after construction***

The vegetated riprap was installed with the "Brushlayering" method. The bank was laid to a slope somewhat less than the desired finished grade and a key trench was excavated down to an elevation level with the lowest part of the channel. The rock toe was then placed in this trench, and a first course of brushlayering was installed at a density of 16-23 stems per linear meter (5-7

stems/ft) and watered. The next layer of stones was placed on top of the initial rocks, but graded slightly back (at the desired slope), and the soil and brush layering process was repeated. Reach B was rocked to the top of the 3.7 m (12 ft) tall slope, as this was judged to be a high stress reach. Reach D, on a less critical bend, was rocked about half way up the 3.7 m (12 ft) tall slope.

The average willow survival rate for Reach A was 17.5%; however, survival of the brushlayers was much higher than the average, and brush mattress survival was much lower. The vegetated riprap at Reach B showed a 24.6% average survival. Reach D (Brushlayering with Rock Toe) had an average survival of 34. The average survival of the brush mattress and willow wattle at Reach E could not be determined, but it was noted to be similar to Reach B, which experienced a 24.6% survival. The

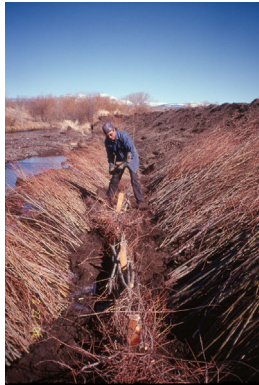
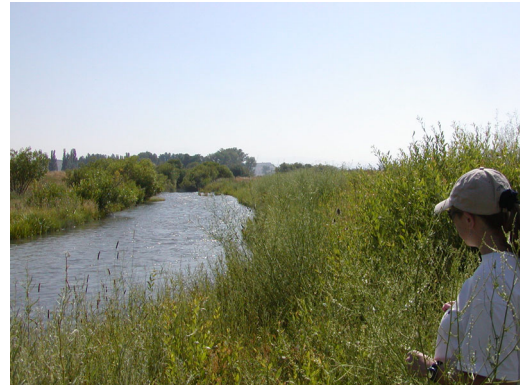
*LLL-Reach A Project: During and After Construction of Live Siltation, Willow Wattle, and Brush Mattress*

In Reach A, a gravel bar had formed mid-channel, and was redirecting flow into the streambank, which was consequently experiencing severe erosion. The gravel bar was removed, placed at the toe of the adjacent bank, and secured with brushlayers, which were to slow water and encourage sediment deposition. Willow and Cottonwood pole plantings were placed at the back of the toe. Upstream of the gravel bar, a 107 m (350 ft) long vertical cut-bank, the relict of the old levees, was laid back at a 2:1 slope, and stabilized with a brush mattress. At the toe of the brushmattress, one rank of live siltation was installed, and both treatments were secured with a continuous 30 cm (1 ft) diameter willow wattle. The levee relicts were removed, and the excess earth was

A V-shaped trench was excavated just below the Mean High Water level, parallel to the toe of the streambank. A thick layer of willow branches was laid in the trench, such that 1/2 of the length of the branches was above the trench and the branches angled out toward the stream. A minimum of 40 willow branches per meter (12 branches/ft) were placed in the trench. The branches were backfilled over with a gravel/soil mix and the top was secured with a willow wattle.

The willow wattle and brush mattress installed at LLL - Reach A was similar to that installed at Bushey, Reach E.

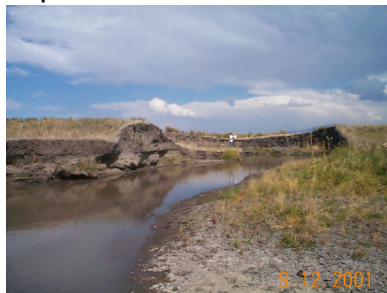
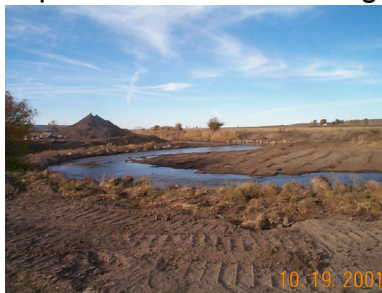
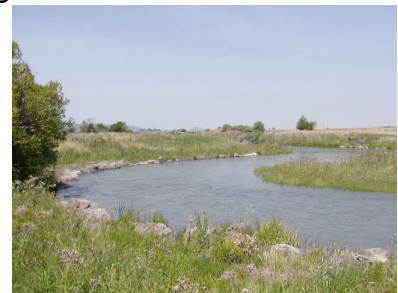
*LLL-Reach B Project: Before, During and After Realignment and Installation of Brushlayering with Rock Toe*

Along the main channel, the levees and stranded flood plains were dropped an average of about 1.2 m (4 ft) with a self-loading scraper. Spoils were graded into the new hay meadow. A gravel bar that had formed and grown into an island mid-channel was removed, and placed at the toe of the bank that it had eroded. The sod growing on it was salvaged for placement later. The meanders that had been carved into the

levees were narrowed, and more stable meanders were installed. All outer bends were armored with a rock toe with brushlayering, and all point bars were graded back, such that the tops were at Mean High Water. Sod was collected from point bars and the island; when the project was done, these were placed over the brushlayers, and watered in.

Different site conditions dictated that the brushlayering with rock toe be installed differently at LLL - Reach B, than it was at the Bushey Ranch. At LLL, the toe helped to define the new bank, when the river was realigned; therefore, a single row of rocks was placed where the new bank was desired. Tops of the rock toe were placed approximately at the bankfull level. Willow cuttings were placed behind these rocks, and soil from the old banks was backfilled behind the rocks. This soil was watered in by taking scoops of water from the river with the excavator bucket, and dousing the newly-planted willows. After the willows were watered in, sod plugs that had been removed when the point bars were graded back, were placed just behind the brushlayers, and the whole thing was watered in again.

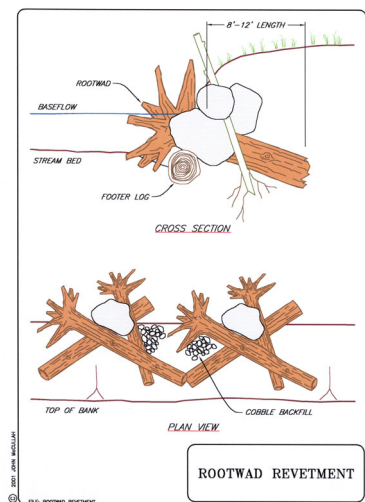
A backhoe was used to set a “footer” log in a trench excavated below the thalweg, running roughly parallel with the bank. A second log, with the root wad attached, was set on top of the footer log diagonally, with the root wad end pointing upstream into the flow, and the butt end lying downstream 45-60° degrees. The butt end of the root wad was set in a trench excavated into the bank, and large boulders and willow poles were used to secure it. Subsequent rootwads in the revetment were installed in a similar fashion, progressing from downstream up. The

willow poles were placed into the excavations to ensure they were deeply embedded and able to contact the water table.
