**Hampton Roads
District
SWM Basins
Inventory & Inspection
Manual**

2005

A. Phase 1 – SWB Initial Assessment

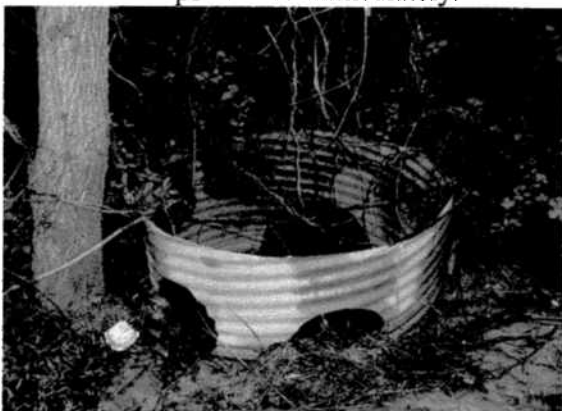
Riser chamber w/excessive amount of sediment
