## WOODY VEGETATION AND RIPRAP STABILITY ALONG THE SACRAMENTO RIVER MILE 84.5-119<sup>1</sup>

*F. Douglas Shields, Jr.*<sup>2</sup>

**ABSTRACT:** Stability of vegetated and bare riprap revetments along a Sacramento River reach during the flood of record was assessed. Revetment damages resulting from the flood were identified using records provided by the U.S. Army Corps of Engineers and verified by contacts with local interests. Vegetation on revetments along a 35.6-mile reach was mapped using inspection records and stereo interpretation of aerial photos taken shortly before and after the flood. A follow-up field inspection was conducted in September 1989. Revetment age, material, bank curvature, vegetation, and damage were mapped from a boat. Mapping results from both 1986 and 1989 were placed in a data base. About 70 percent of the bank line of the study reach was revetted. About two-thirds of the revetment was cobble; one-third was quarry stone. Revetment vegetation varied from none to large (> 50-inch diameter) cottonwoods. About 10 percent of the revetted bank line supported some type of woody vegetation. Damage rates for revetments supporting woody vegetation tended to be l

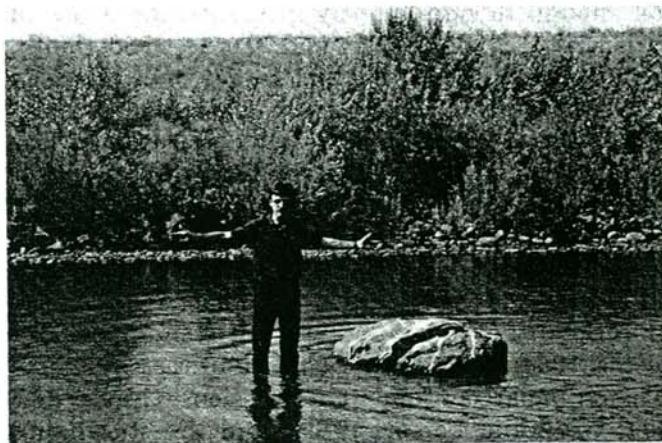
Figure 1. Invasion of Riprap Revetment by Pioneering Woody Species.

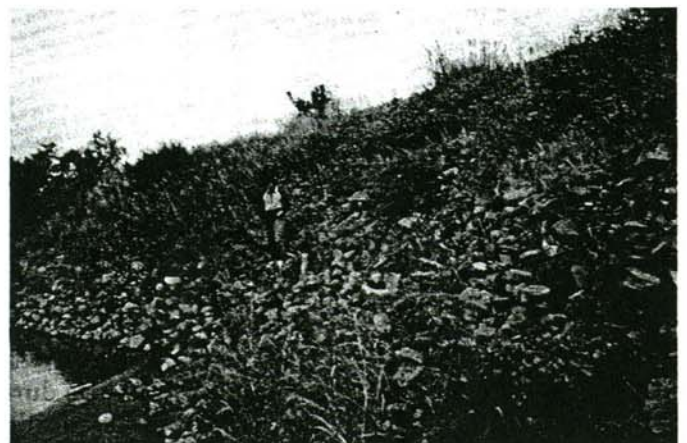
a. Sacramento River Mile 109.25.

b. Sacramento River Mile 92.6.

Figure 3. Range of Vegetative Cover Found on Study Reach Revetments.

Revetments were maintained by groups of landowners ("local interests"), ostensibly to comply with standards that were prescribed by the Sacramento District (1955). Standards for maintenance of levee and revetment vegetation have been a point of controversy for years (Carter and Anderson, 1984). These standards have historically been interpreted as requiring regular removal of all woody vegetation. Although most of the revetments were maintained free of woody vegetation by manual cutting or application of herbicide, a wide range of woody vegetation types, sizes, and densities were present (Figure 3) because compliance with maintenance standards varied.
